Inspection Report

Property Address:
1001 Valley Way
Sugar Hill, GA 30518

**Total Home Inspection
Services, Inc.**
770-317-9881

| Date: 11/14/2011 | Time: 1:45 PM | Report ID: example resale |

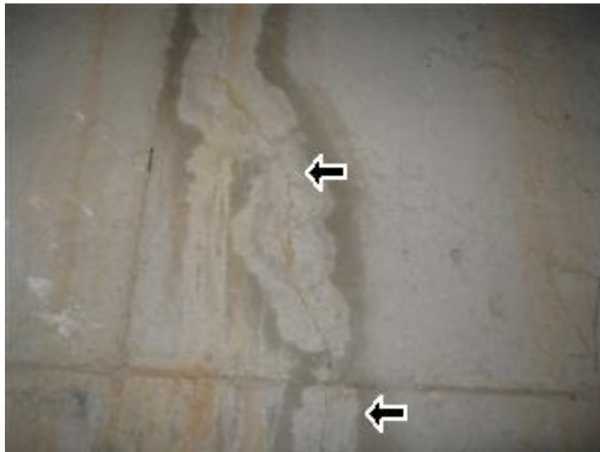
1.1 Picture 1

Several typical hairline cracks seen in the foundation walls and in the basement slab. Some water seepage but no displacement seen around the cracks, monitor for future cracking with displacement around the cracks or water seepage. If so, consult a mason or structural engineer for further evaluation of displacement around the cracks or consult a water proofing company if water seepage appears around the cracks.

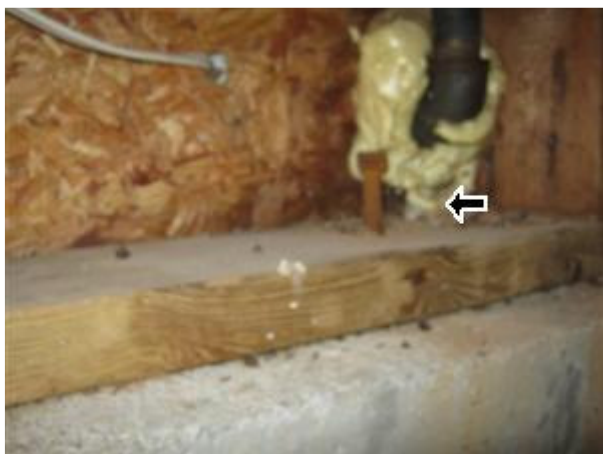
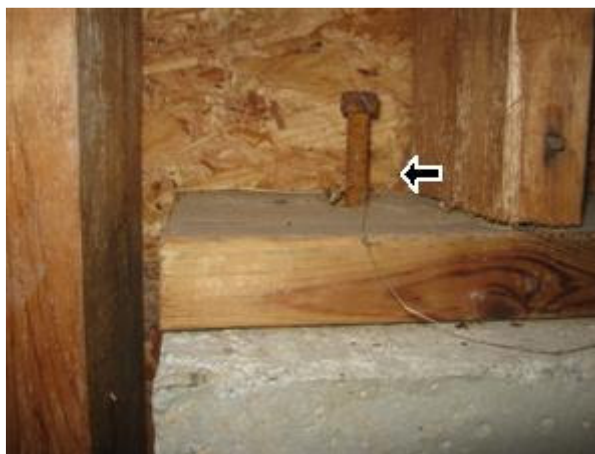
1.2 Picture 1

Foundation anchorage are not secured at rear. When braced wall panels are supported directly on continuous foundations, the wall wood sill plate shall be anchored to the foundation in accordance with this section.

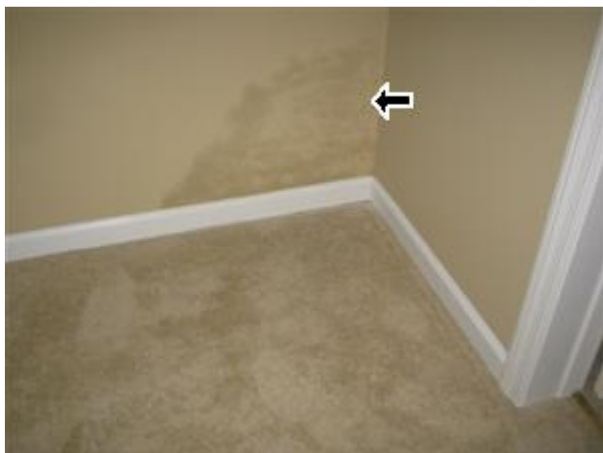
1.3 Picture 1

Visual inspection of what could be a mold and or mildew like substance in the basement area. Most all houses have some mold or mildew but many are treatable. Check the CDC or EPA Web site for possible self treatments. Further evaluation maybe needed by professional in the field.

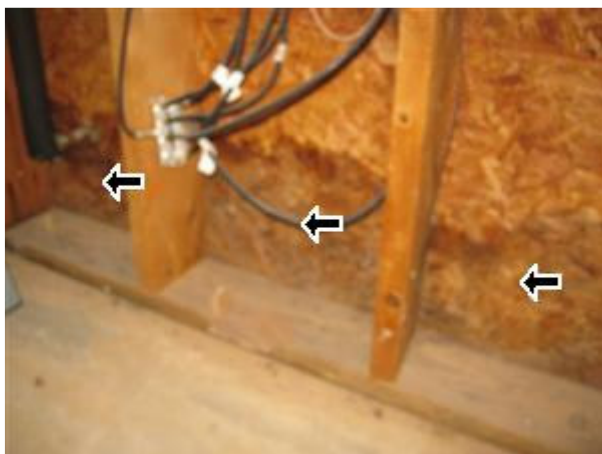
1.7 Picture 1

Moisture stains found on rear wall sheathing at rear of house. Recommend keeping exterior area clear of debris and water to avoid damage.

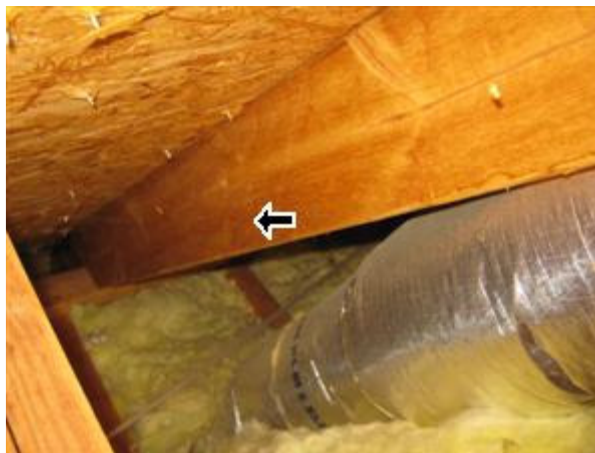
1.12 Picture 2

Water stains on decking and structural members in attic. Recommend monitoring for active leaks and if present have a professional in the field to evaluate and repair as needed.

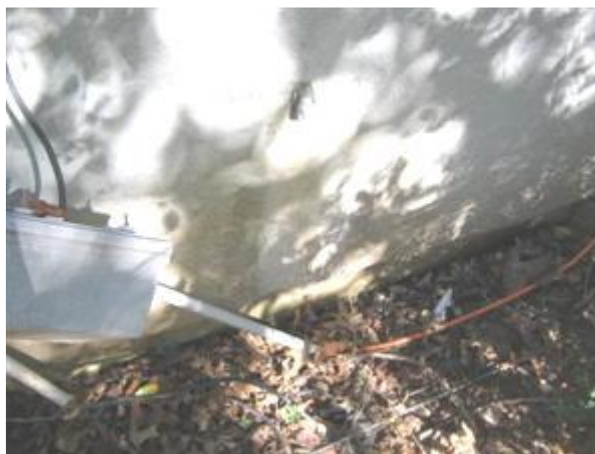
2.0 Picture 4

Seal around all exterior light fixture (and repair those that are loose), water lines, gas line, etc.. to prevent rain water or insects from entering into the wall cavity and behind the synthetic stucco.

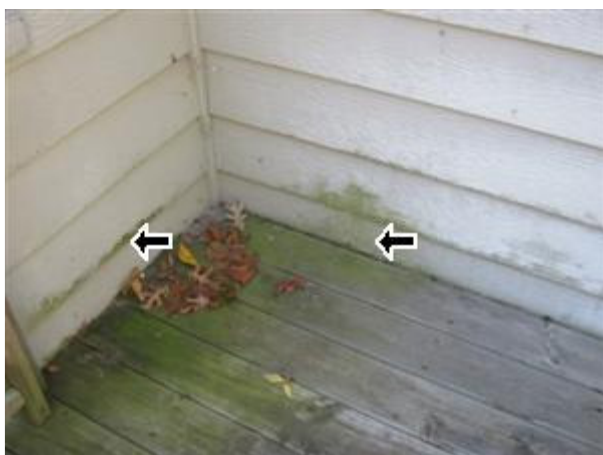
2.1 Picture 1

Mold/mildew like substance found on the wood fiber siding at rear. Recommend treatment or repair.

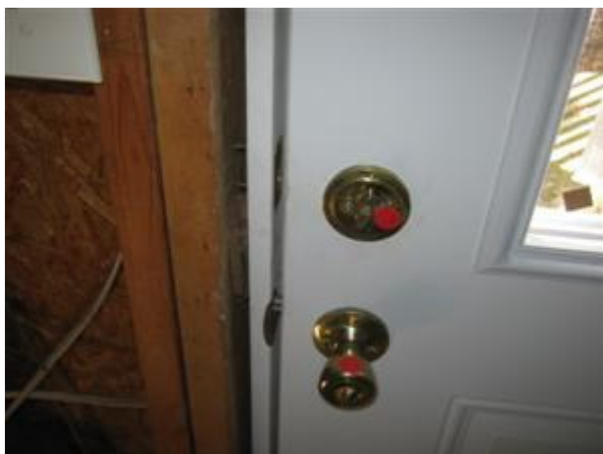
2.5 Picture 3

Both rear doors to the decks have loose or missing hardware. Repairs needed.

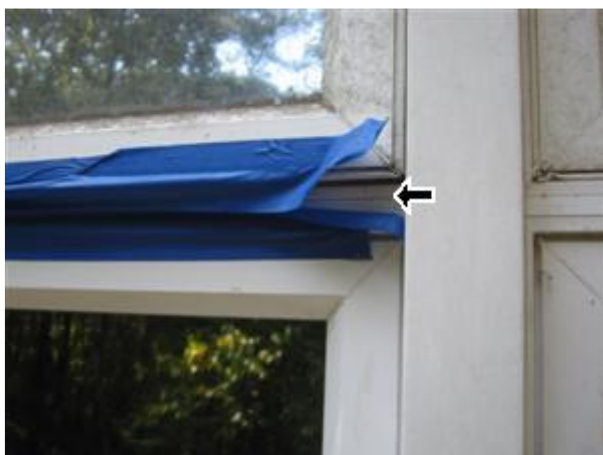
2.6 Picture 1

One of the windows in the basement area will not close, blue tape covering gap on exterior. Repairs needed.

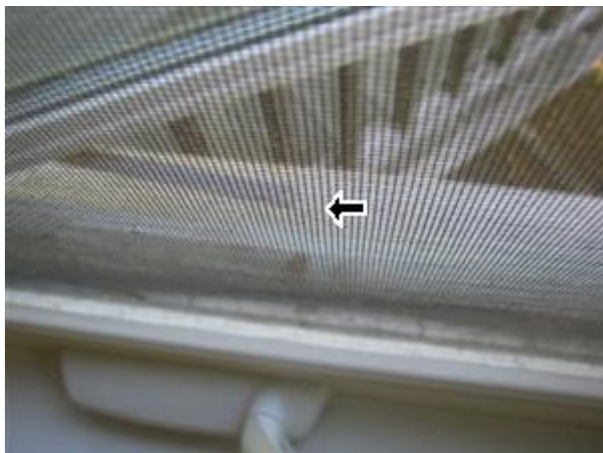
2.7 Picture 1

Hardware is loose at some of the windows. Repairs needed.

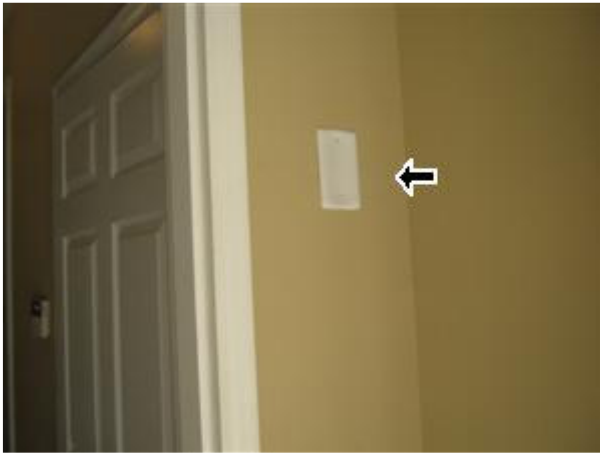
2.8 Picture 1

Garage door openers in place but not operational, no switch or remote found. Repairs needed.

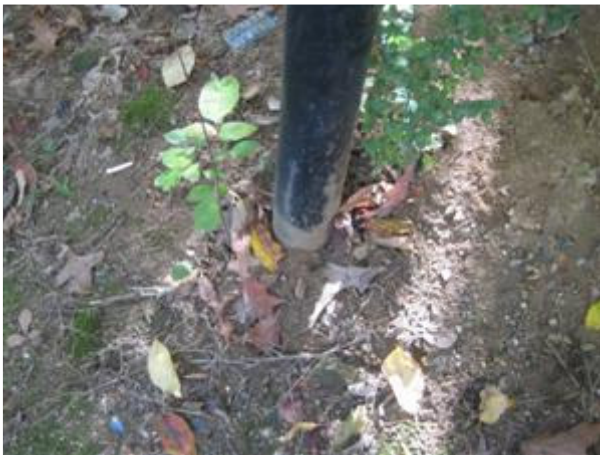
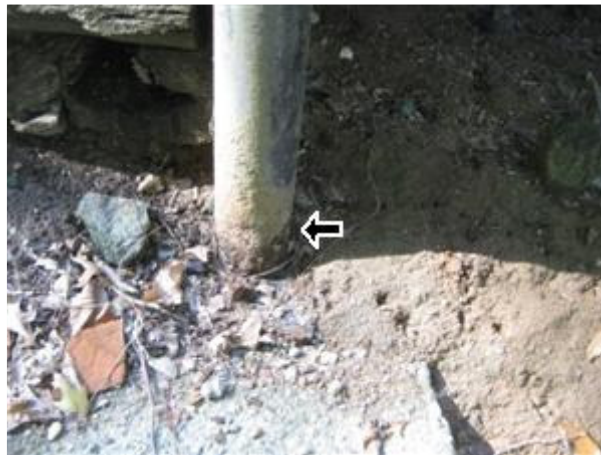
2.10 Picture 1

Rust noted towards the bottom of the metal support posts. Prime and paint is needed. Keep metal posts away from direct ground contact. If the metal posts are rusted through, replacement is needed.

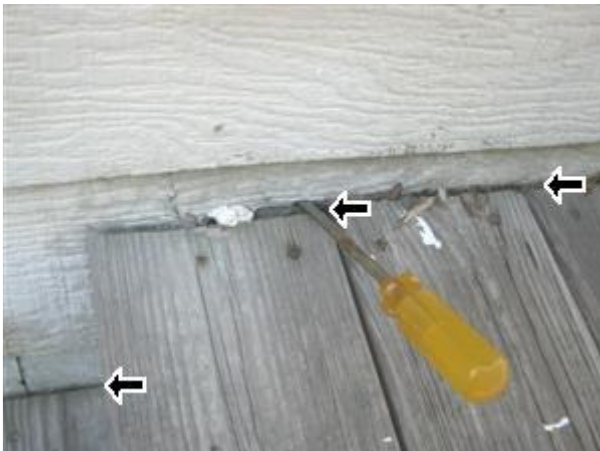
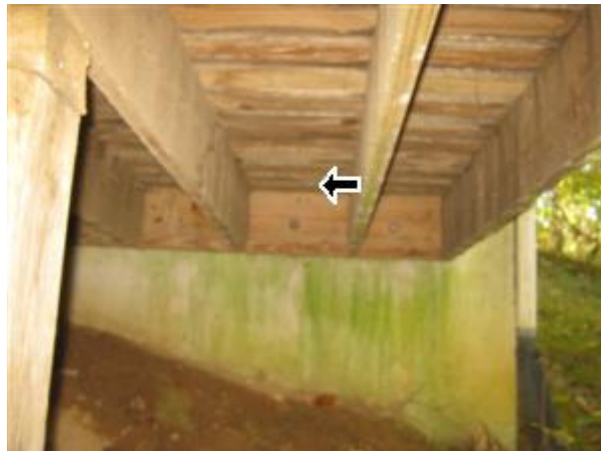
2.11 Picture 1

Deck not flashed at connection to wood frame wall. Current building code requires corrosive- resistive flashing to be installed where the deck attaches to a wall assembly of wood frame construction.

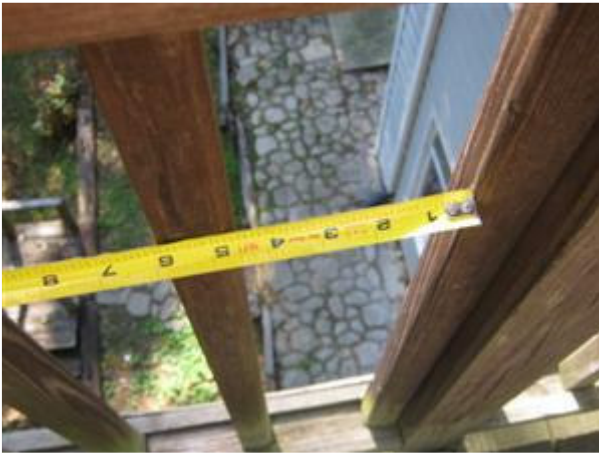
2.12 Picture 1

The deck pickets are spaced over 4", should be 4" or less than in width. Recommend handrail pickets be added.

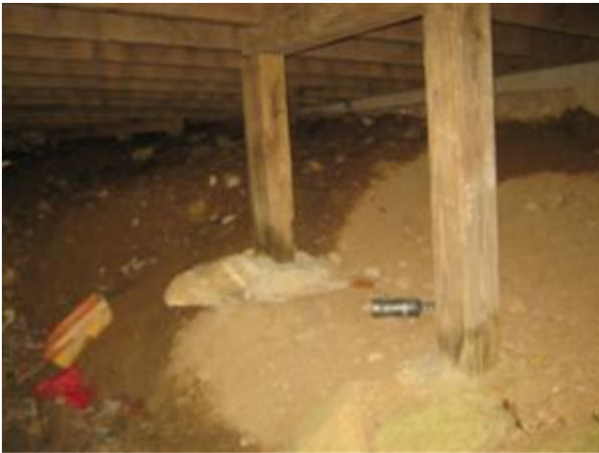
2.13 Picture 1

Additional supports have been added under deck to support the hot tub. Could not determine the weight load of hot tub to determine if supports are adequate

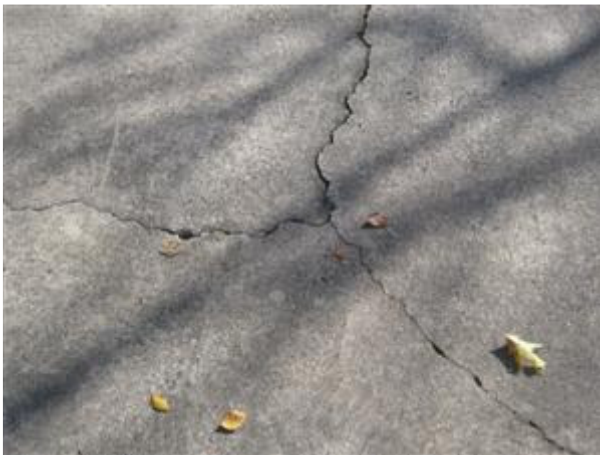
2.15 Picture 1

Typical cracks seen in the driveway, porch, patio. No displacement seen around the cracks. Monitor for future cracking and fill cracks in the winter to avoid water intrusion and freezing.

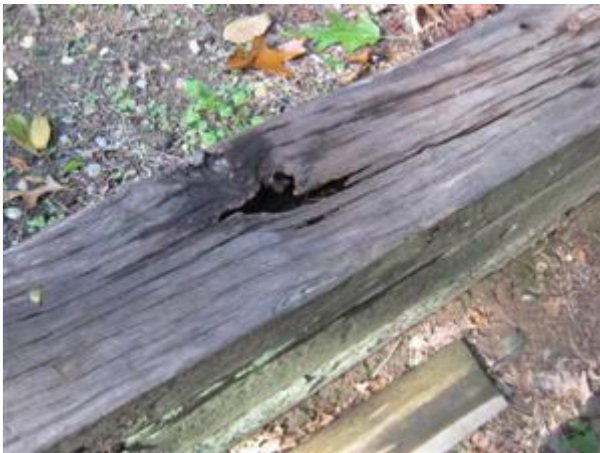
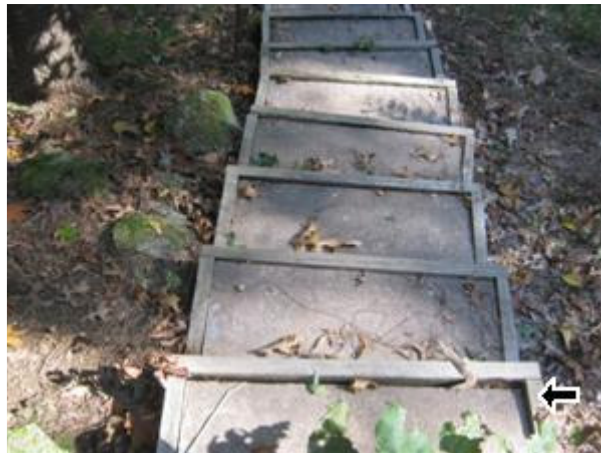
2.16 Picture 1

Wood retaining wall is bowed out in sections, with rotted wood members in areas as well. Consult a Landscaping Co. for further evaluation and repair.

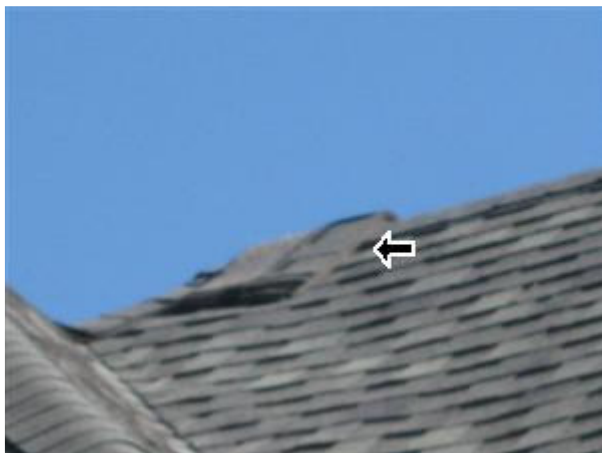
3.0 Picture 1

Extra shingles found on roof peak.

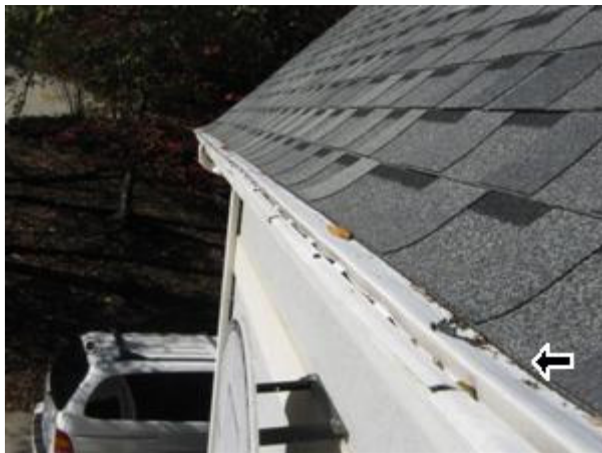
3.1 Picture 1

Could not determine if roof felt is present, edge of roofline is covered by guttering system.

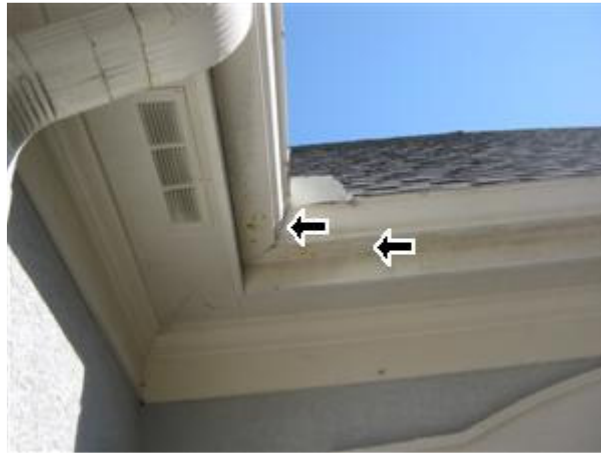
3.2 Picture 2

Gutter has signs of rust but could not determine if leaking. Recommend monitoring during rain to determine if they need replacing. Downspouts extension is not connected, which does not discharge rainwater at least 5 feet away from the foundation. Repairs needed.

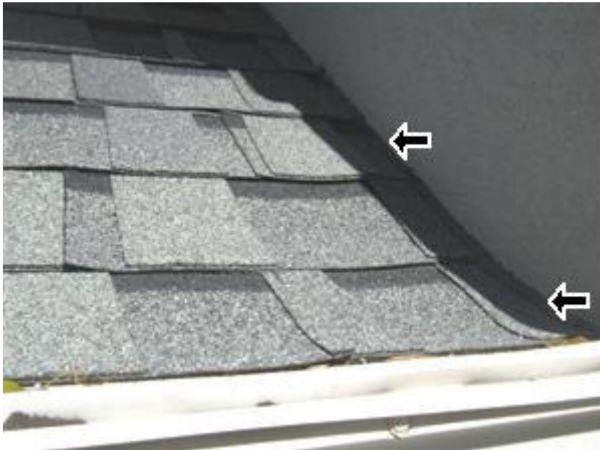
3.3 Picture 1

Sidewall flashing not seen where shingled roof attaches to walls.

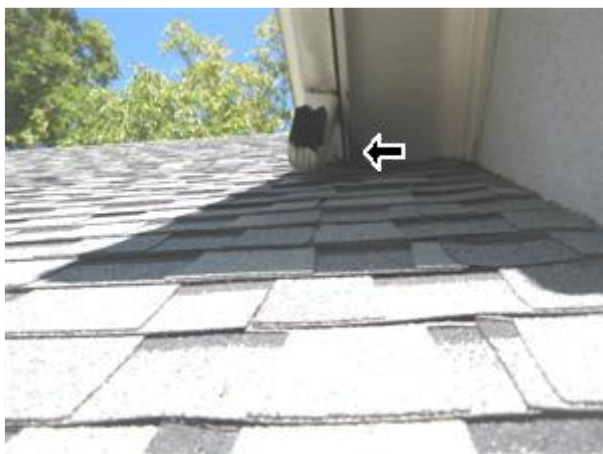
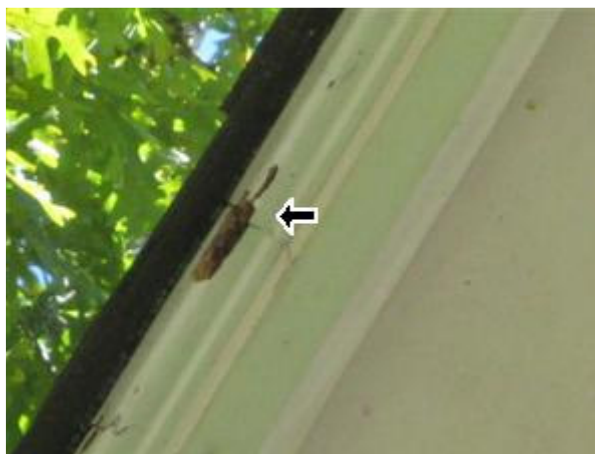
3.6 Picture 1

Rot noted in the fascia/soffit boards located at the

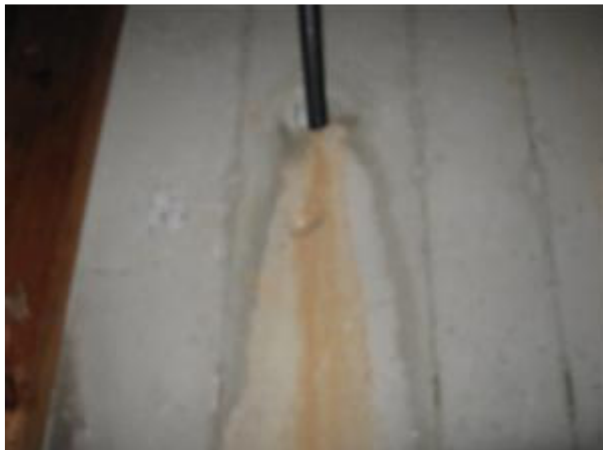
4.2 Picture 1

Water stains found on foundation wall where the service line enters the basement area. This may have been from prior leak. Monitor for leaks.

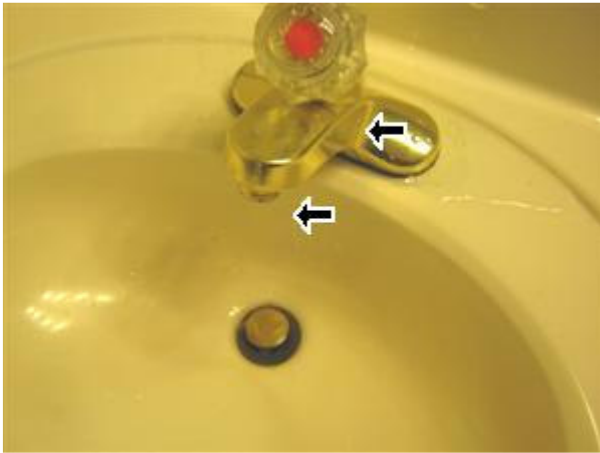
4.5 Picture 1

Leaking and dripping sink fixture found at master bathroom. Repairs as needed.

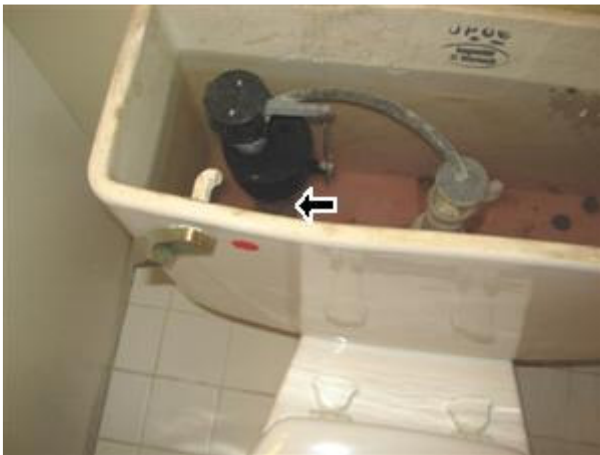
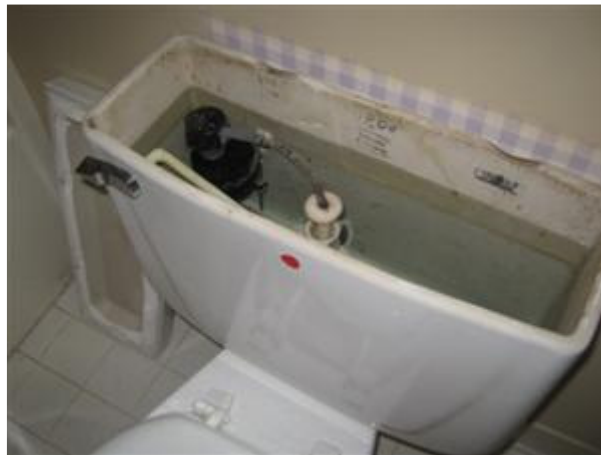
4.6 Picture 1

Toilet at first floor bathroom would not operate properly, handle pull was missing. Repairs needed. Running toilet found in the upstairs J&J bathroom. Consult a plumber for further evaluation.

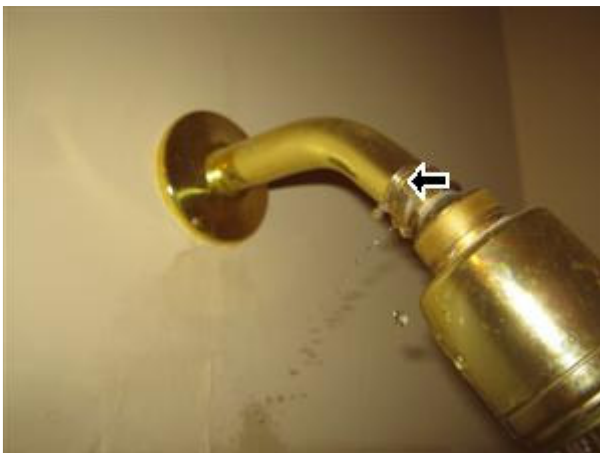
4.7 Picture 1

Shower heads leak at J&J bathroom.

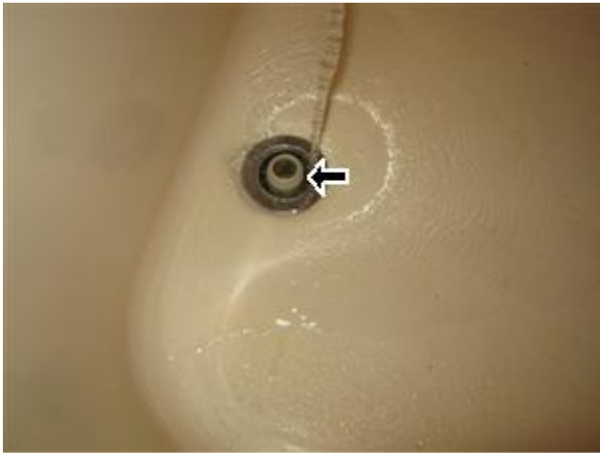
4.8 Picture 1

Drain stopper is missing in the bathtub.

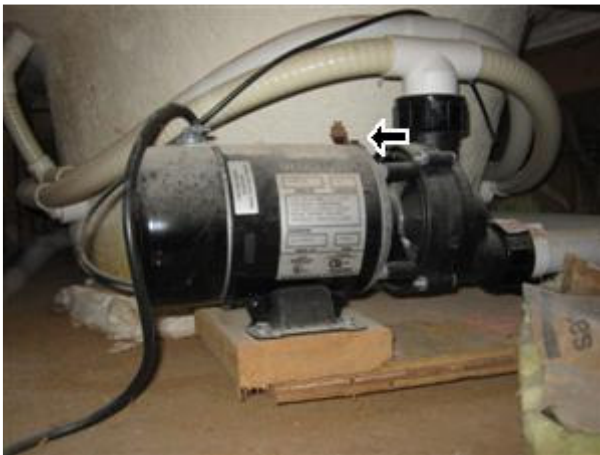
4.10 Picture 1

Electrical bonding wire not seen connected to the set screw on the whirlpool pump.

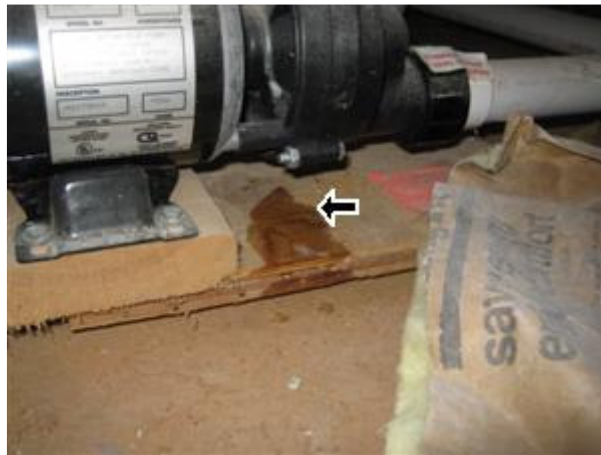
4.10 Picture 2

Water leak found at motor of jetted tub. Repairs needed.

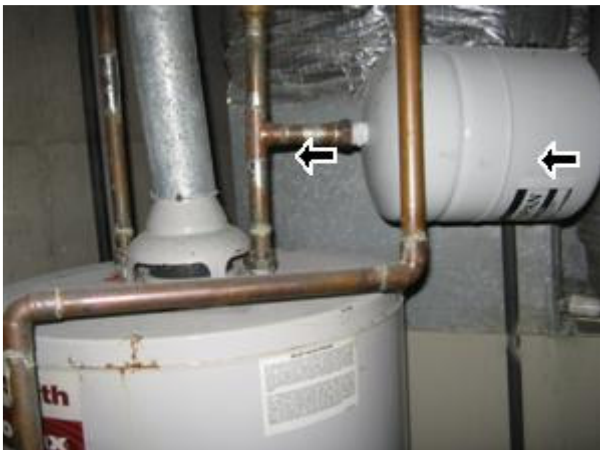
4.13 Picture 1

Thermal expansion tank needs strapping (securing) separate from its own supply line.

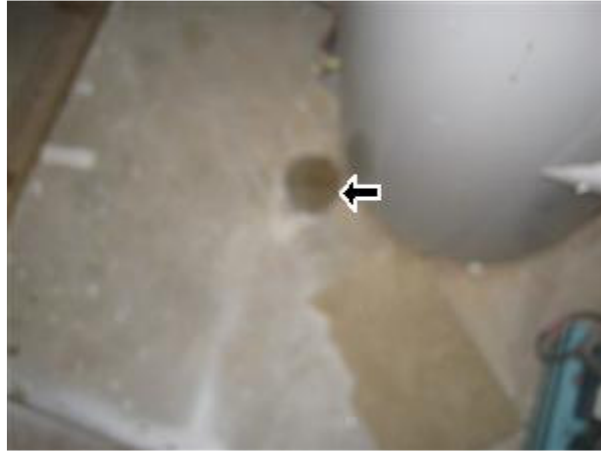
4.14 Picture 2

Water heater had water leak at the T/PR valve. Unit was off when entering house. Turn unit on and tested fixtures. Water heater was turned off before leaving house.

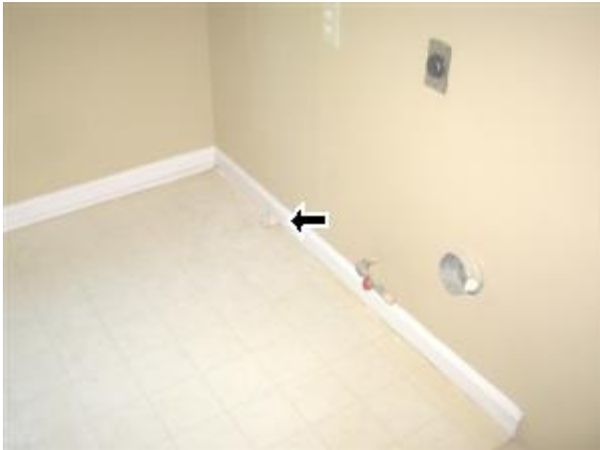
4.15 Picture 1

Missing a drain pan under the washing machine.

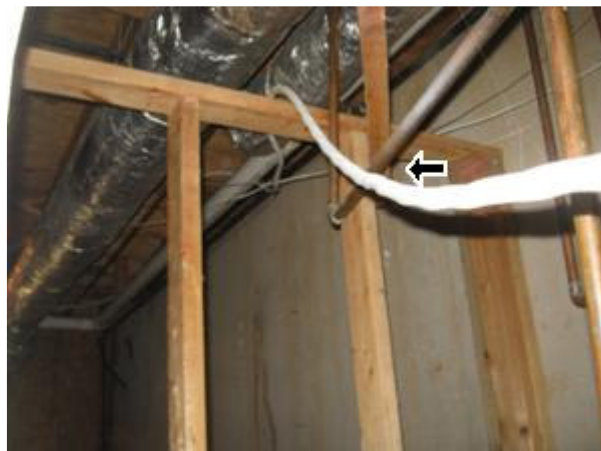
5.2 Picture 4

Missing a wire clamp on the new white wire located at the top of the panel box. Clamps are needed. The same wire is connected to a different breaker 50 amps(Siemens) than the panel (Sq. D). The same wire is not properly secured through the basement unfinished area.

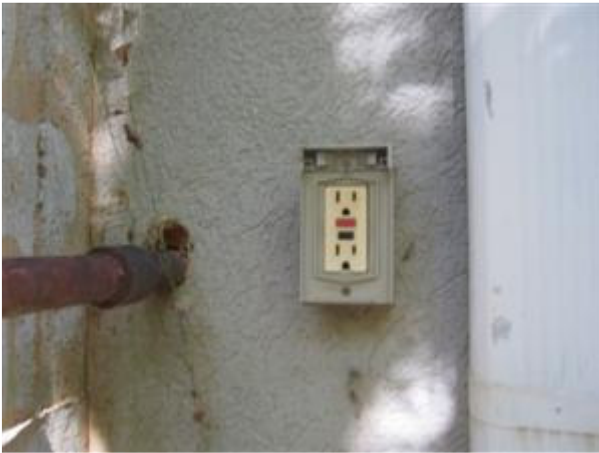
5.3 Picture 1

Cover is missing on exterior panel at right side of house, safety concern. Cover should be installed.

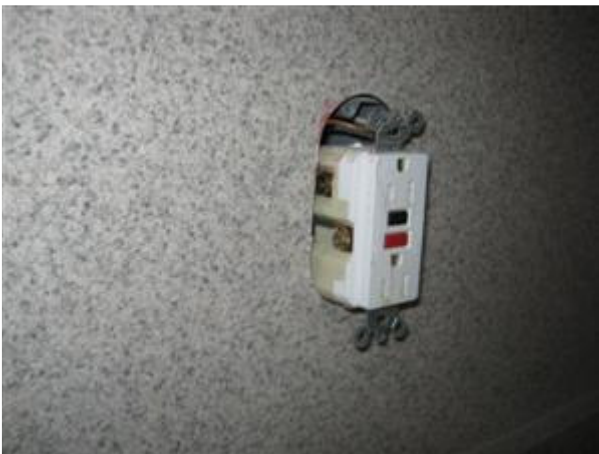
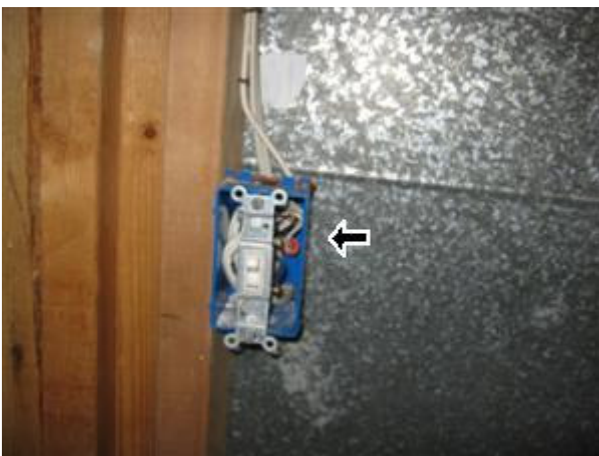
5.4 Picture 1

Loose outlets marked with sticker seen in the kitchen. Securing of the outlet(s) is needed.

Cover plate damaged or missing on receptacles and switch plate through the house, safety concern. Replacement needed.

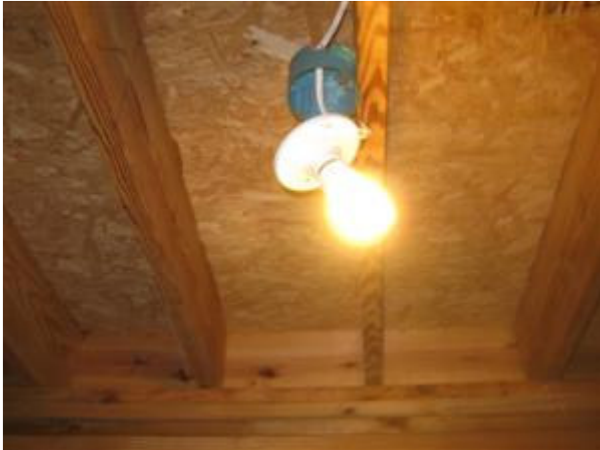
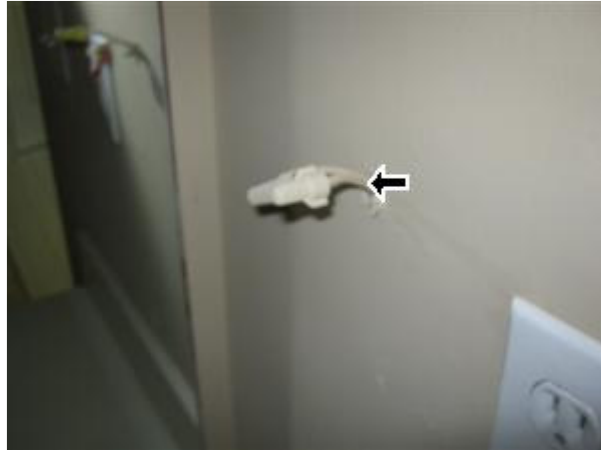
5.5 Picture 1

Many of the light fixture were not functional at the time of the inspection. Recommend changing bulbs and retesting.

Loose light fixture found in basement area, repairs needed.

Exposed wiring found in master bathroom. Sealing is needed.

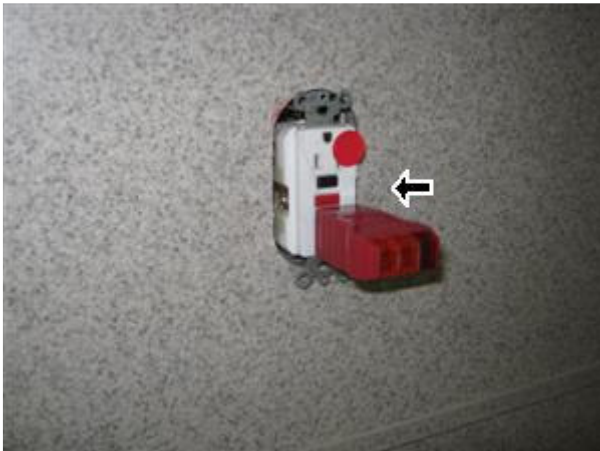
5.6 Picture 1

The marked G.F.I. outlet is not tripping off when tested. Consult a Certified Electrician for repair.

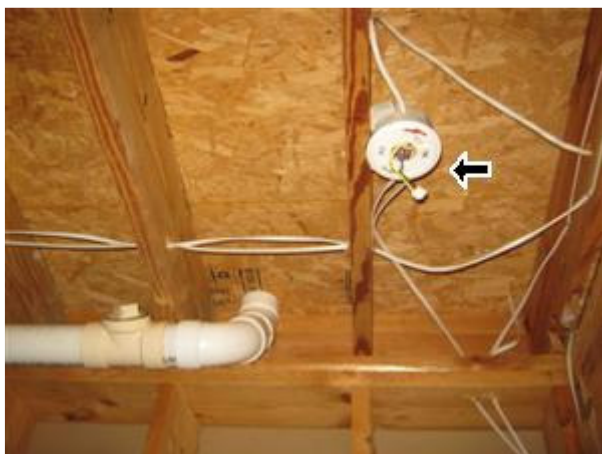
5.7 Picture 1

Smoke detector were beeping at the time of the inspection. Recommend installing new batteries.

All smoke detectors should be tested upon moving in to home. Smoke detector missing in basement area. Replacement needed.

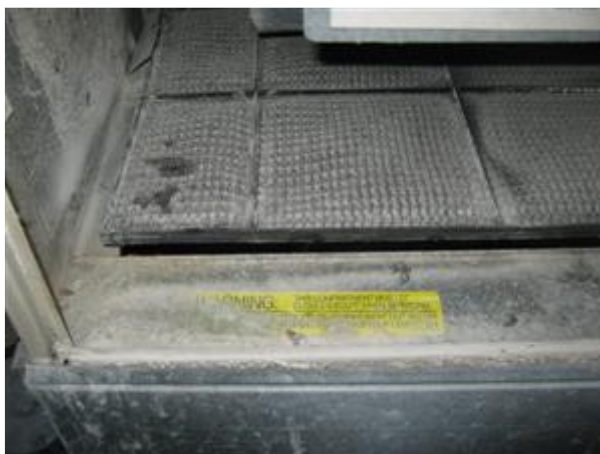
6.1 Picture 1

The Filter is dirty and needs cleaned or replaced in attic and basement.

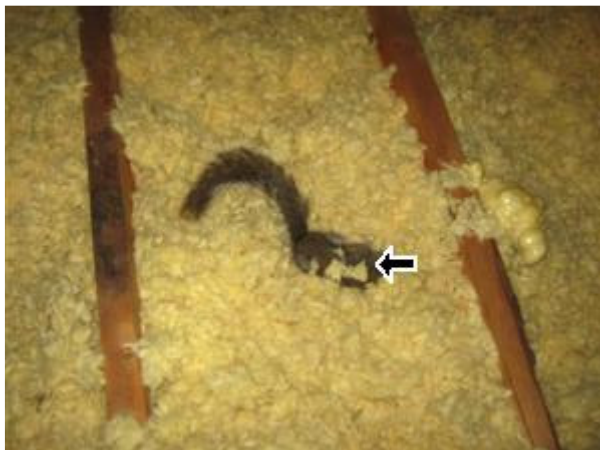
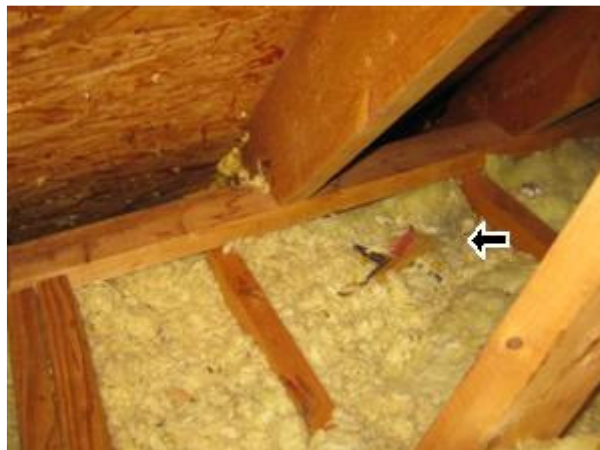
8.0 Picture 1

Dead animal found in the attic as well as signs of prior problem.

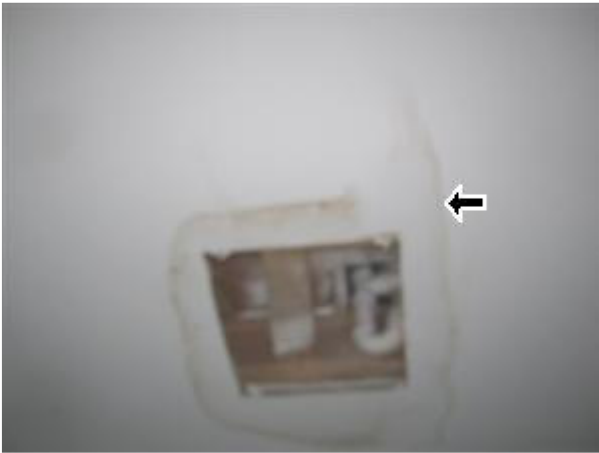
8.1 Picture 1

Water leak repaired in the dinning room ceiling but hole in ceiling with water stains visible. Repairs needed.

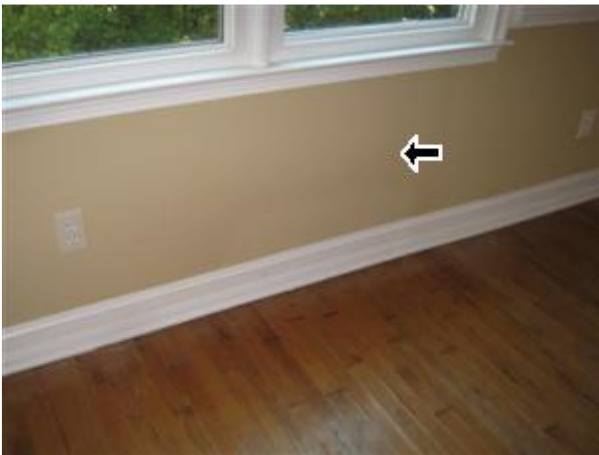
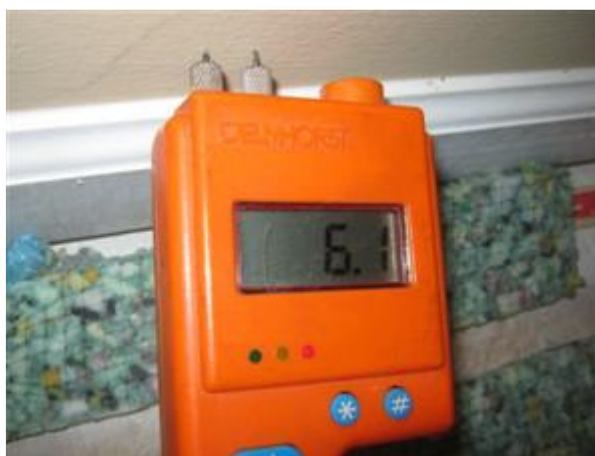
8.3 Picture 1

Water stained walls seen in the dinning room and master bedroom as well as the walls below the dinning room in the basement area. Area(s) tested for moisture with a Delmhorst Moisture Meter. Area(s) rate of moisture detected was 2.3 -6.1%. Repairs or replacement needed.

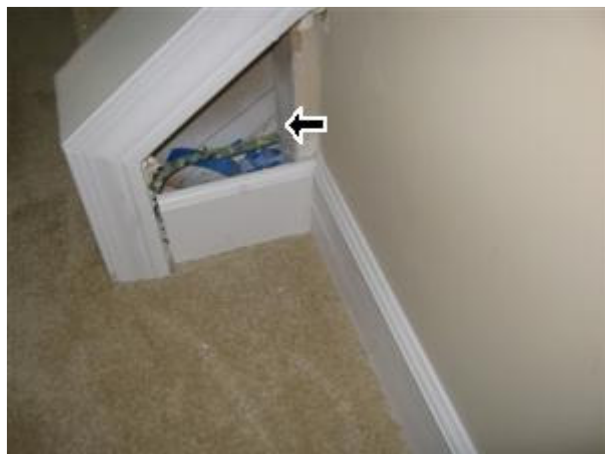
8.5 Picture 1

Wall covering missing in basement area.

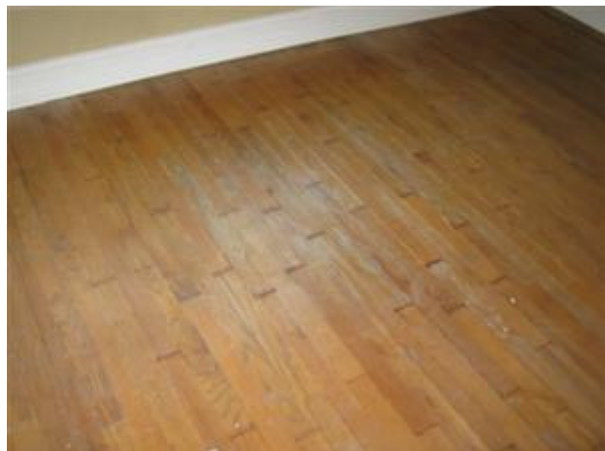
8.6 Picture 1

Water damage on wood floor covering in dinning. Repairs needed.

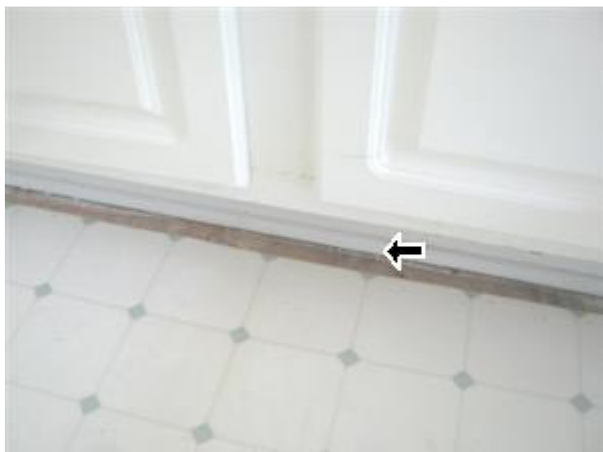
8.8 Picture 1

Floor cover is pulling away from wall in kitchen. Replacement needed.

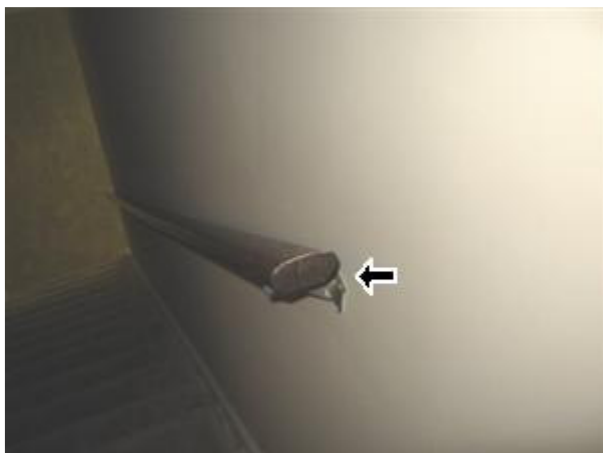
8.9 Picture 1

The handrail on steps to basement are not turned back to the wall, safety concern. Recommend repairs.

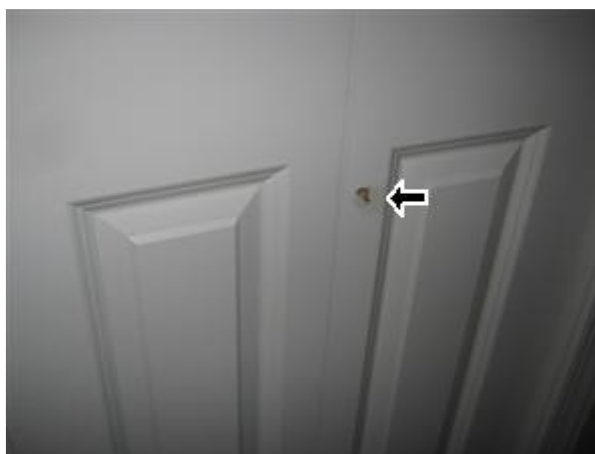
8.12 Picture 4

Door stops are missing at several locations throughout the house. If not replaced, wall damage can occur.

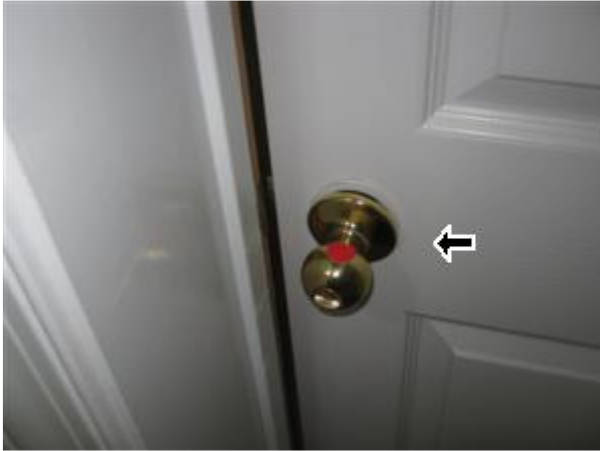
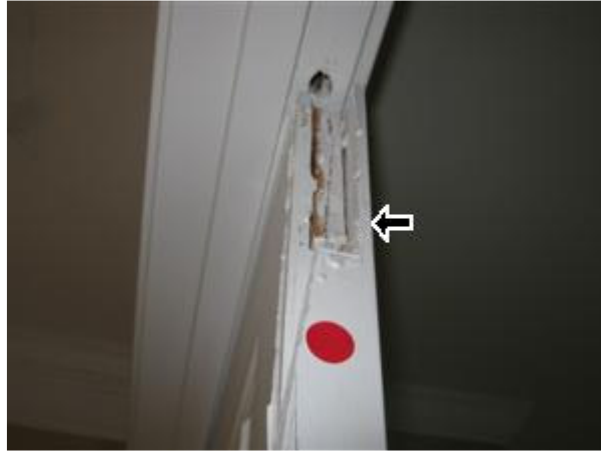
8.13 Picture 1

Marked door handles are loose . Damage on master bedroom door where lock has been removed. Repairs needed.

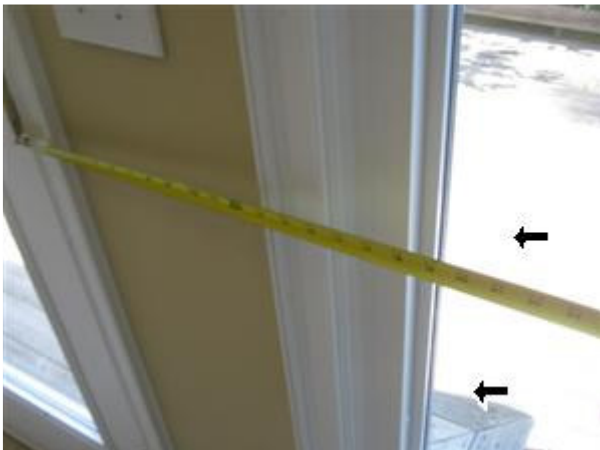
8.17 Picture 1

The window next to the door to the deck is not equipped with temper glass. Tempered glass is now required within 24" of the arc of a door in a closed position.

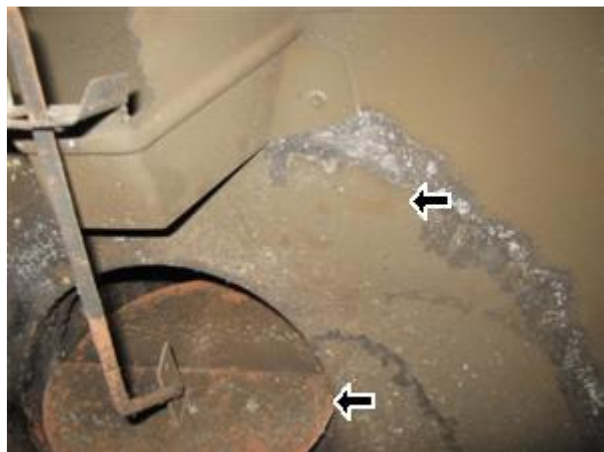
8.18 Picture 1

The fireplace damper has signs of rust. Recommend review by roofer to determine if there is opening in chimney or this is from prior leak that has been repaired.

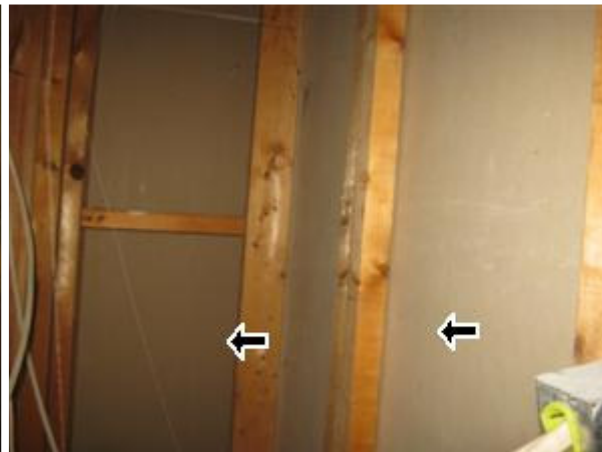
9.0 Picture 2

Insulation is missing in some areas of basement and attic, reinstall insulation where needed.
