SITE INSPECTION- 8/13/19

# 19<sup>TH</sup> FAIRWAY

Eileen Jacobs- Mountain Caretakers, INC.

August 21, 2019

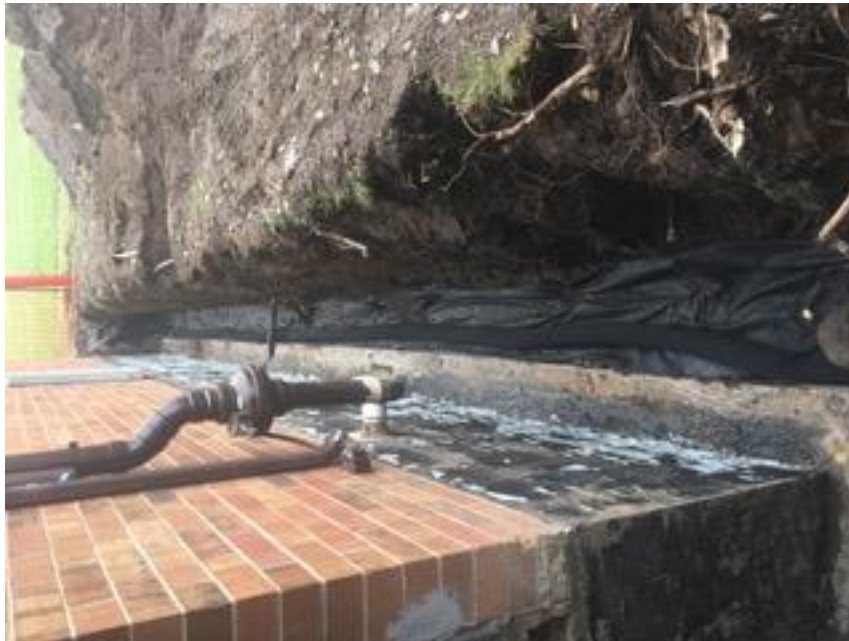
- Building A & B are constructed with approx. 5ft. of the lower level below grade. The concrete slab is approx. 4” thick. Concrete Masonry Unit (CMU) block rest on the slab and the CMU forms stem walls that support the structure. The slab is continuous and extends approx. 6” past the CMU on the exterior side of the foundation. The shelf on the exterior slab can act to channel water under the CMU into the lower level of unit #1 thru #18.

*Excavation of Unit #9 West side in 2018 showing 6” exterior shelf on the concrete slab*

**Building A & B**- The original design of Building A & B with the 6” exterior shelf on the concrete slab is problematic. This shelf tends to channel water under the CMU block into the lower level of these units.

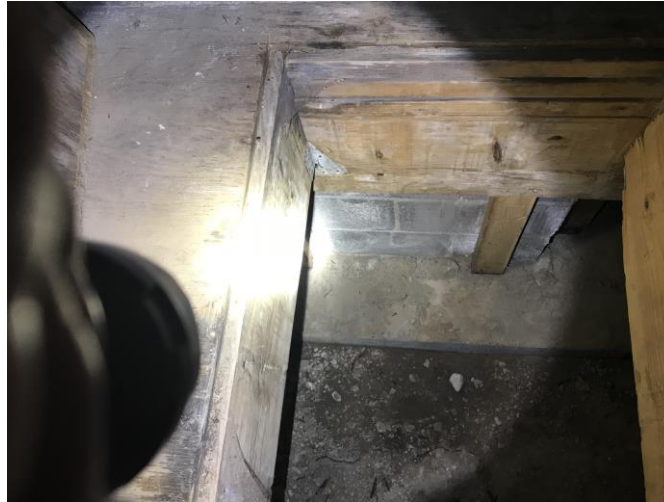
- Building C has a crawlspace under the lower level flooring and this flooring is wood framed. There is a perimeter concrete footer located approx. 3 ft. below the wood floor in the lower level. This is a better construction method for Building C since any water infiltration that does occur will be located in the crawlspace and not damage lower level flooring materials.

*View of crawlspace and footer in Building C-unit #19*

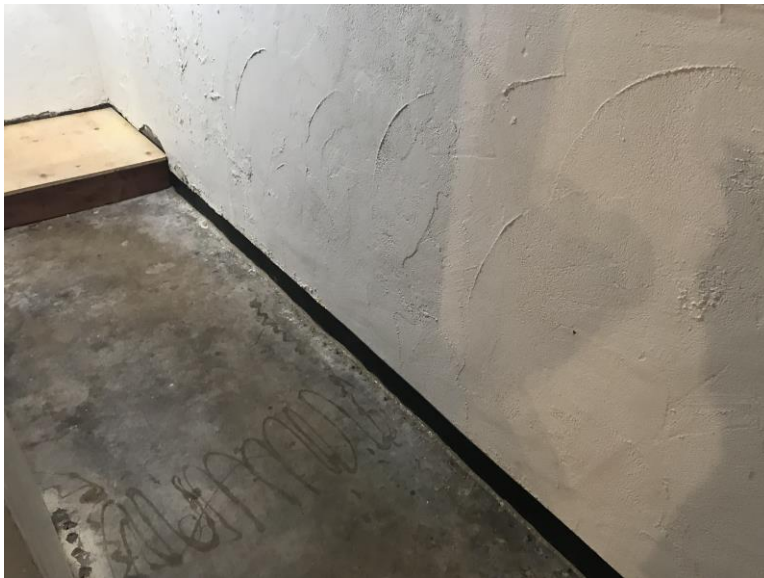
#4- Front repaired by Aspen Foundations in 2018- installed 30 ft. of perforated drain pipe and dry pit located approx. 25' from foundation. Leaked after the 2018 repair initially due to soil grade towards building and incomplete downspout. Soil grade, downspout and interior sealing repairs were performed and no leakage after the follow-up repairs.

*#4 wall repaired in 2018- dry in 2019. Some evidence of salts on surface of wall that have been observed for many years.*

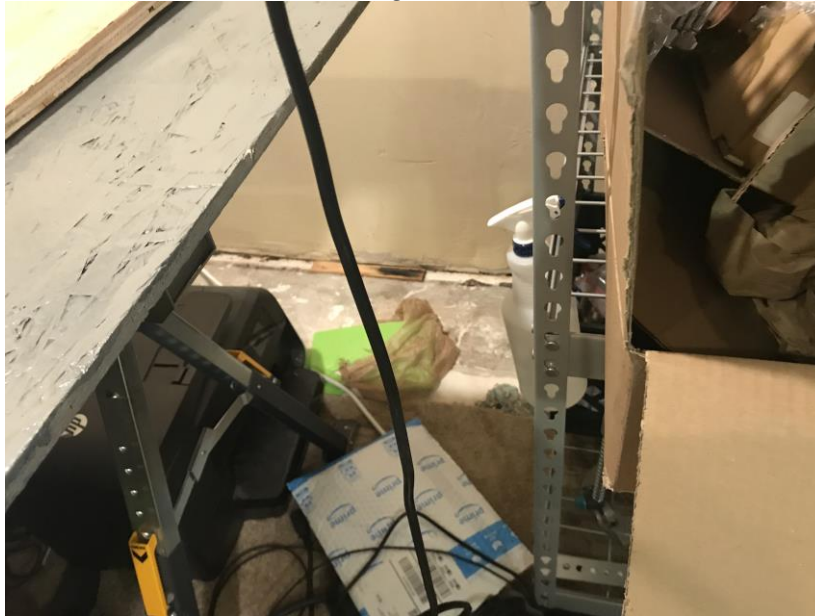
#5- Leakage on the back side in 2019 and in previous years. The leakage occurs in the Spring with snow melt.

*#5 rear corner leakage that occurred in 2019*

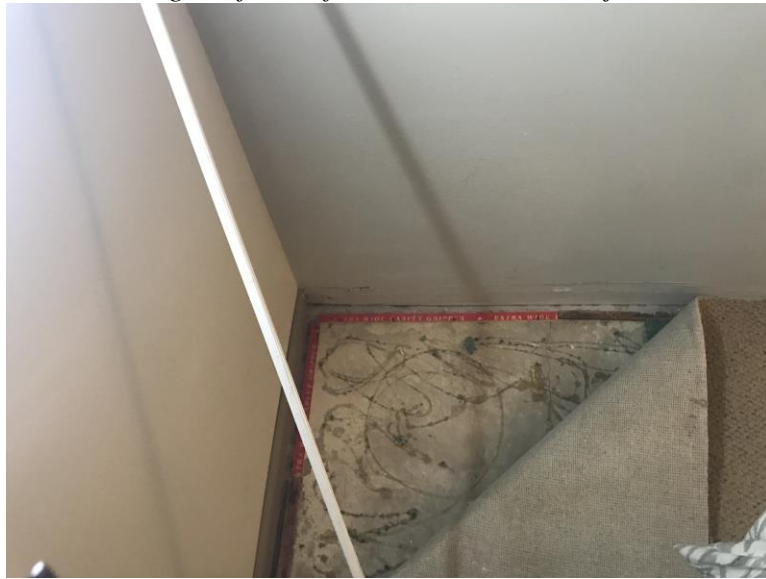
#9- Perforated pipe installed by Aspen Foundation in 2018 on the side and front of unit with integrated drywell approx. 20 ft. from the foundation. Closet and area under stairs was dry along with the sump pit. No leakage of area repaired in 2018 occurred in 2019. Water infiltration was observed in 2019 that appears to have originated in Unit #10 and carried into Unit #9.

*2019 water damage in front of Unit #9 at corner adjacent to unit #10*

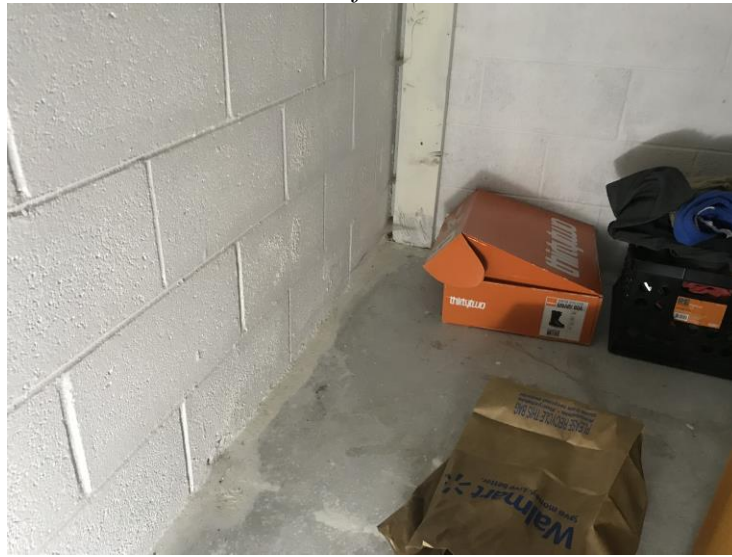
#10- Front side leak on June 15th,2019 after heavy rainstorm that carried water into unit #9.

*Evidence of water in #10*

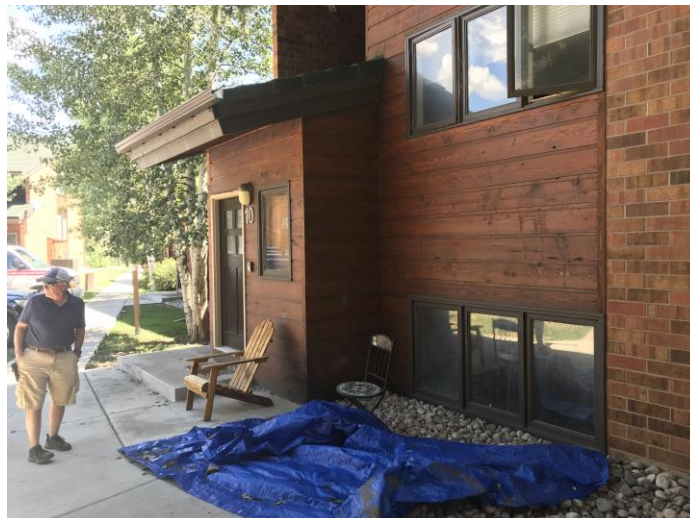
*#10 gutter over entrance-no downspout & blue tarp located to move water away from foundation.*

2. Install gutters at the correct height with maximum 20 ft. length front and rear of Building A&B.
3. All gutters to have downspouts that deposit water flow at least 8ft from the foundation.
4. If there is continued water infiltration from hydrostatic pressure after all the grading and gutter work is completed, then excavation and sealing of the foundation could be completed as Phase 2.

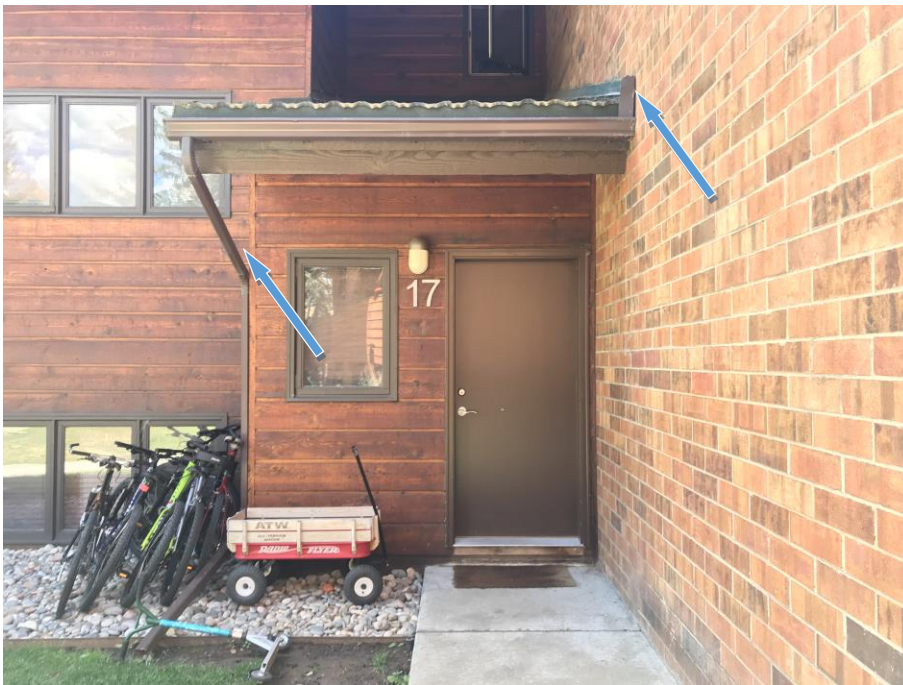
#16- Front leak 5-6 years ago and flashing and downspout was added to the gutter over the entrance of #17 and this corrected the problem for #16. Water was observed running down the wall at the foundation.

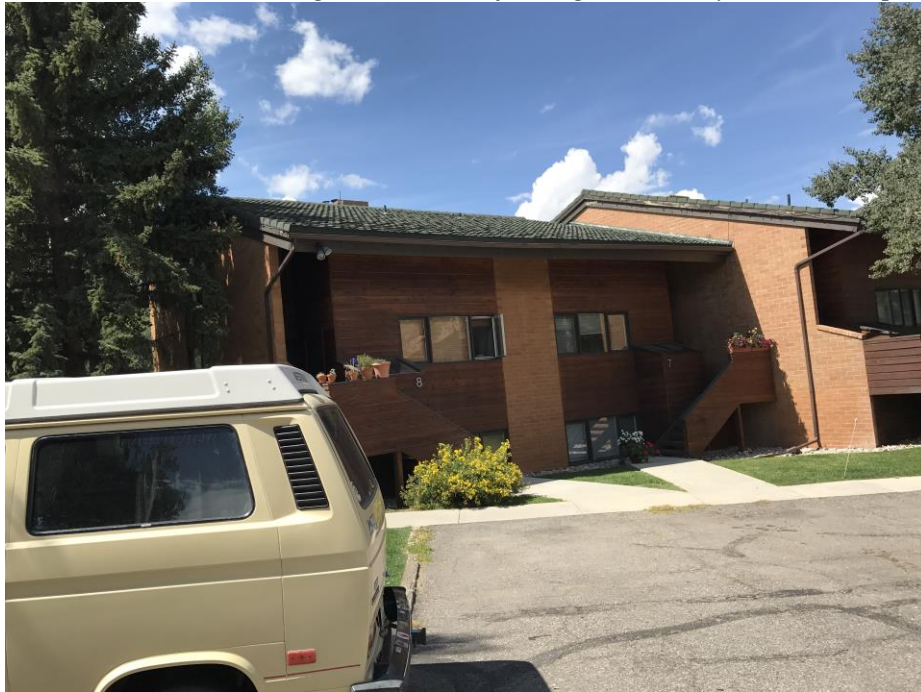
- A & B building do not have gutters and downspouts on the rear of the building.
- C-Building has gutters and downspouts on the front and rear of the building.
- All three buildings have significant overhangs on the eaves of the roofs. No overhangs are present on the rake edges.
- The Gerard stone coated metal roof was installed on wood battens without removing the previous roof material. The roof elevation changed (raised) by approx. 3” and the gutters were now located too low in some locations to catch significant storm water flowing off of the roof.
- Gutter length is typically 40 ft with only one downspout- Maximum 20 ft. length of gutter with downspout is recommended.

*Gutters over unit #8- 4” gutter with 40 ft. length and only one down spout*

A & B building has excessive 40 ft. length gutters located at an incorrect height to capture large water flows off of the roof.

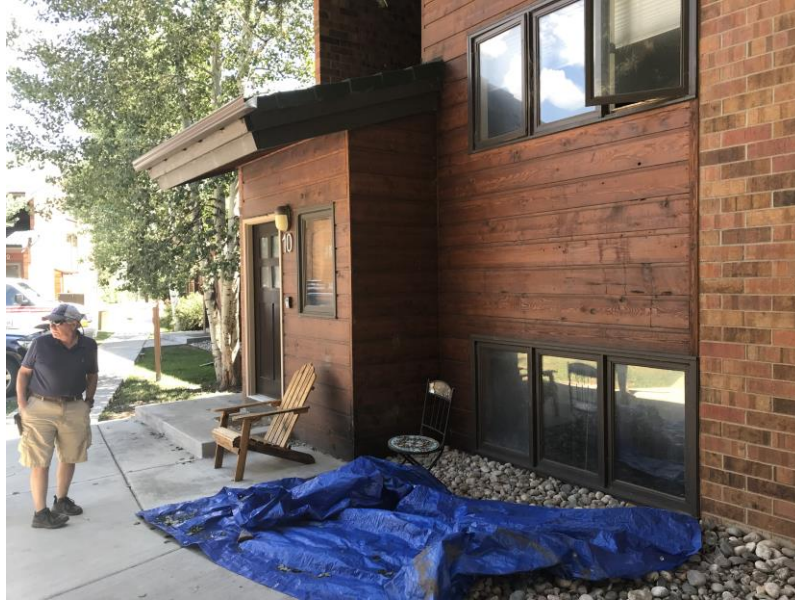
- Gutters over the entrance doors on Building B do not have downspouts.
