Inspection Report

Property Address:
1001 Valley Way
Sugar Hill, GA 30518

**Total Home Inspection
Services, Inc.**
770-317-9881

| Date: 11/14/2011 | Time: 1:45 PM | Report ID: example resale |

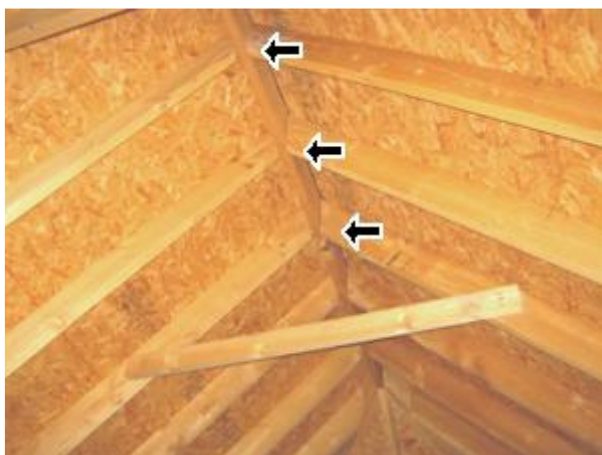
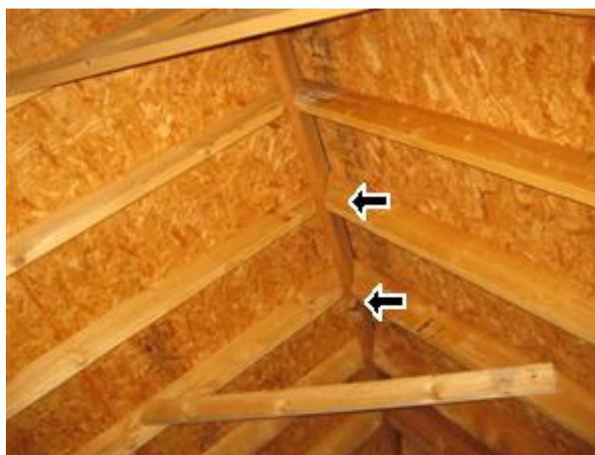
1.11

Top ends of the roof rafters hang down below the bottom of the ridge board. Additional 2x2 is needed to the underside of the ridge board.

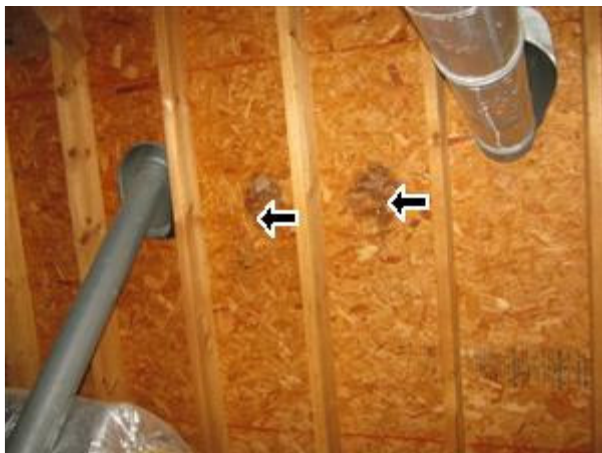
1.12

Water stains on decking and structural members in attic. Recommend monitoring for active leaks and if present have a professional in the field to evaluate and repair as needed.

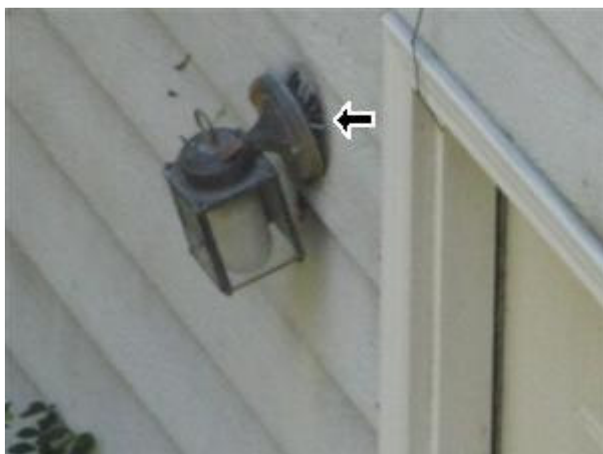
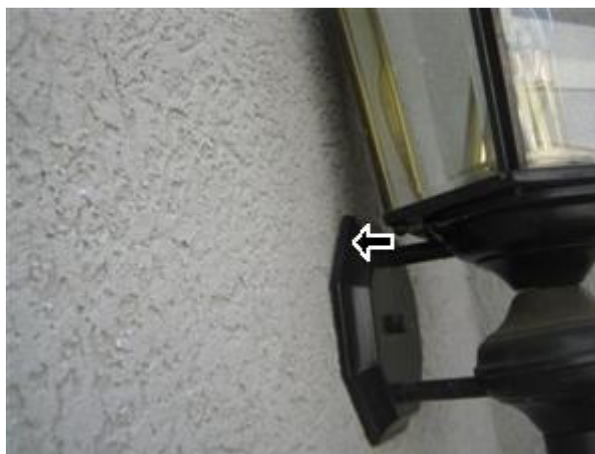
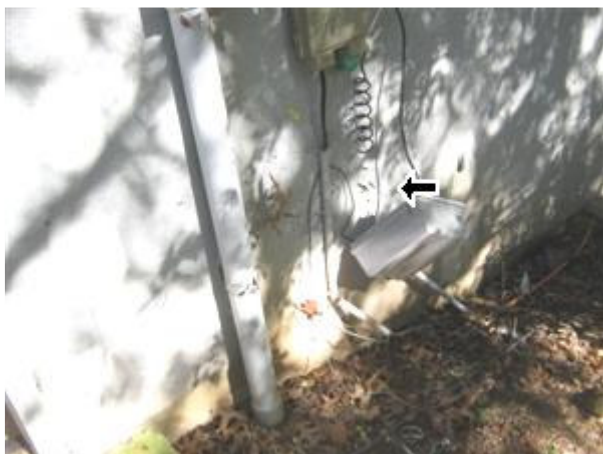
2.0

Seal around all exterior light fixture (and repair those that are loose), water lines, gas line, etc.. to prevent rain water or insects from entering into the wall cavity and behind the synthetic stucco.

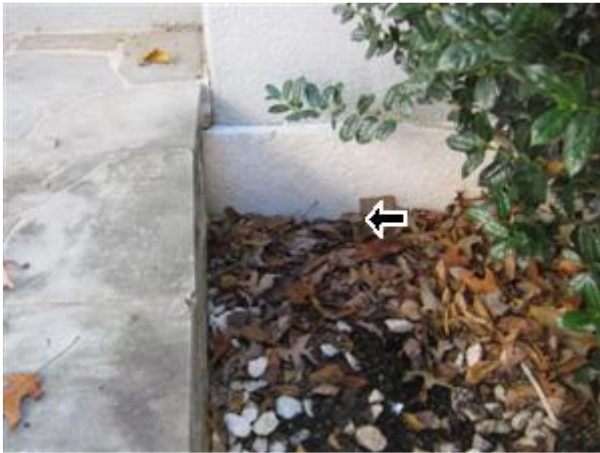
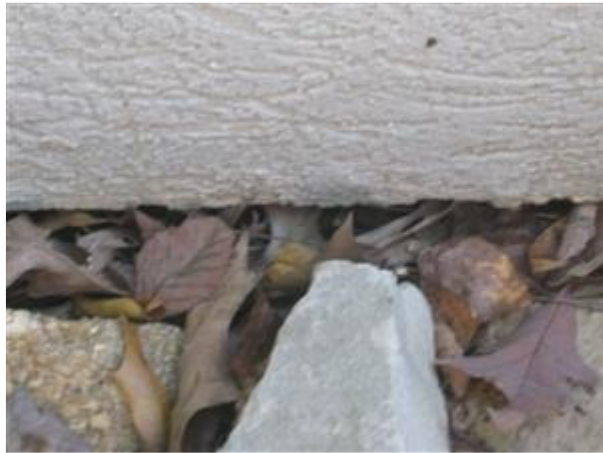
2.3

E.I.F.S. siding is in contact with concrete, wood, ground etc... Proper clearance needs to be obtained, if not proper sealant is needed at all junctions with E.I.M.A. approved sealant such as Dow Corning 790 series caulk.

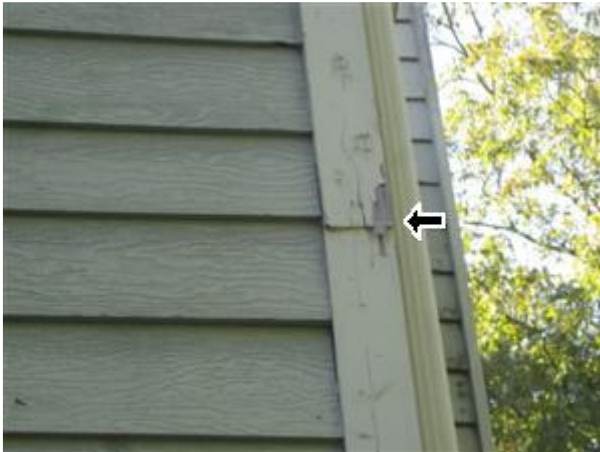
2.4

Painting and/or sealing is needed on the exterior of the home.

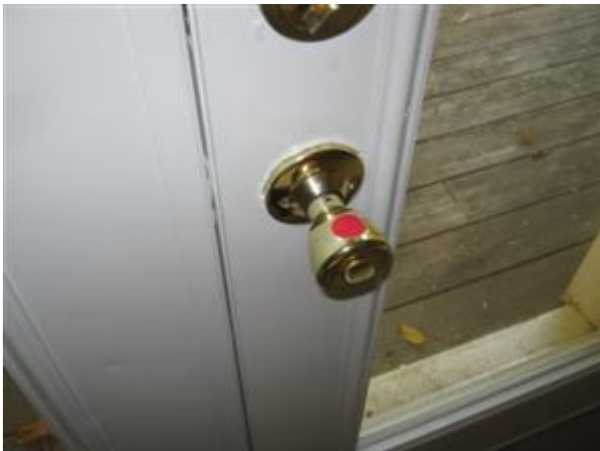
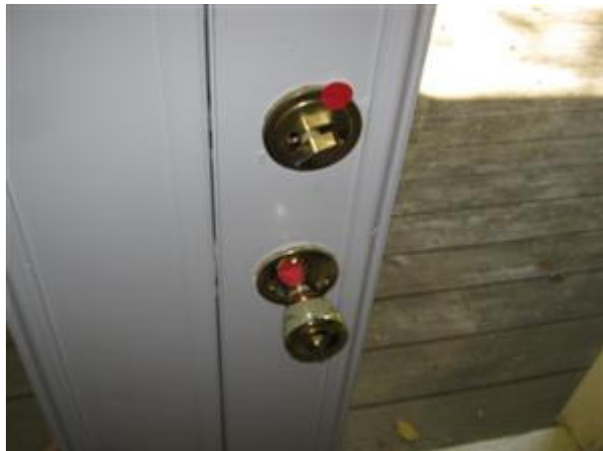
2.5

Both rear doors to the decks have loose or missing hardware. Repairs needed.

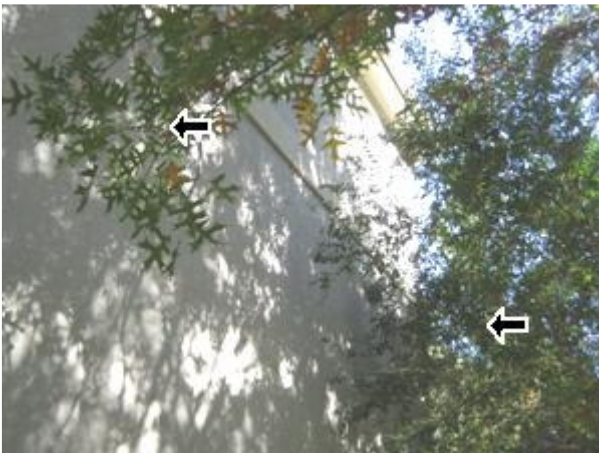
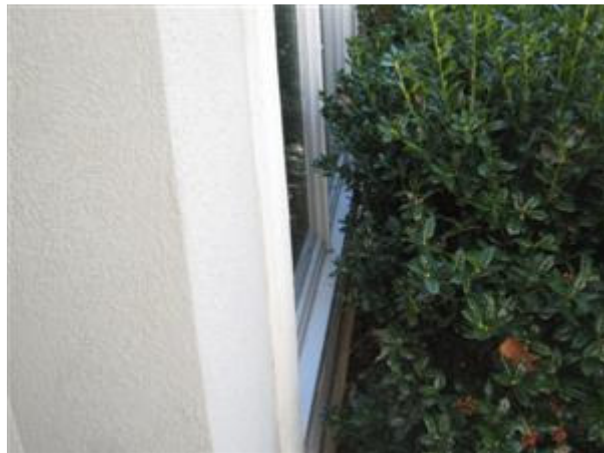
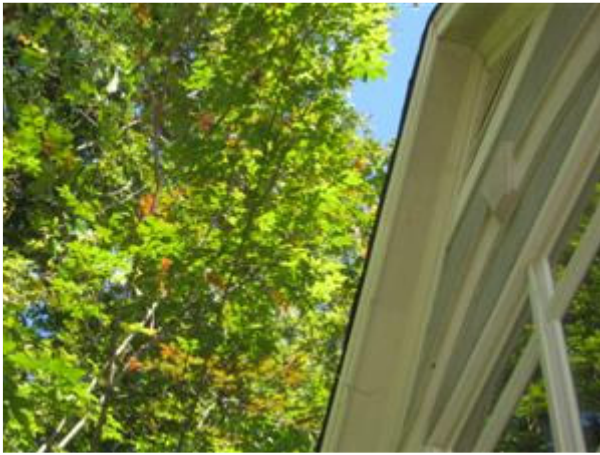
2.14

Removal of the vegetation that is in contact with the siding on the home is needed. Limited view to the siding in these areas.

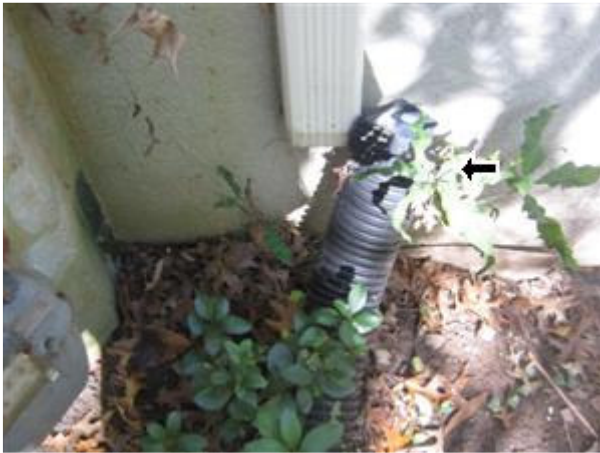
3.2

Gutter has signs of rust but could not determine if leaking. Recommend monitoring during rain to determine if they need replacing. Downspouts extension is not connected, which does not discharge rainwater at least 5 feet away from the foundation. Repairs needed.

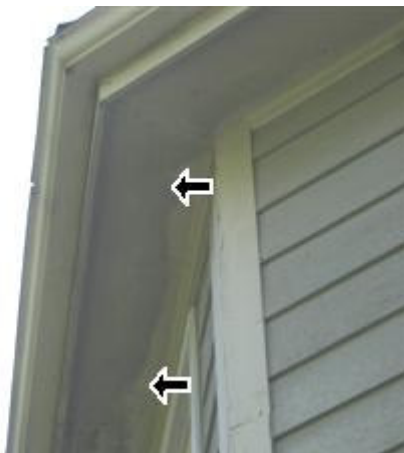
3.5

Signs of moisture noted in the fascia/soffit boards at rear of house. This could be a sign where the gutters are backing up. Recommend professional in field review for recommended repairs.

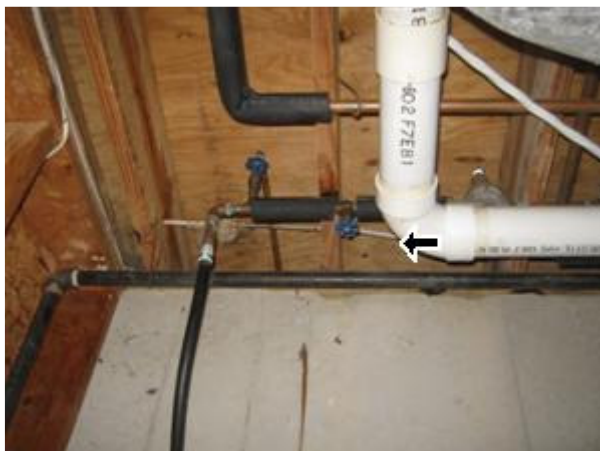
4.1

Water stains found on foundation wall where the service line enters the basement area. This may have been from prior leak. Monitor for leaks.

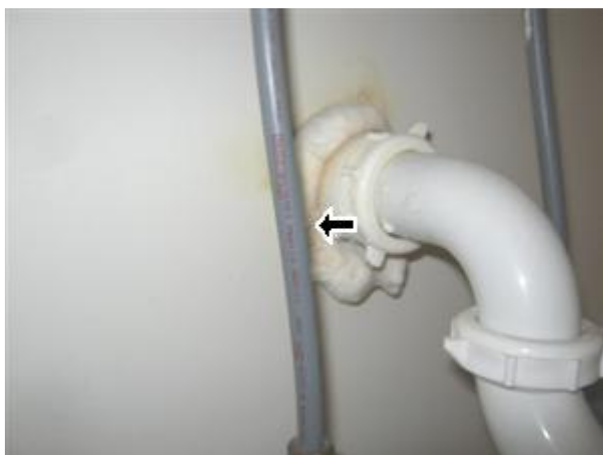
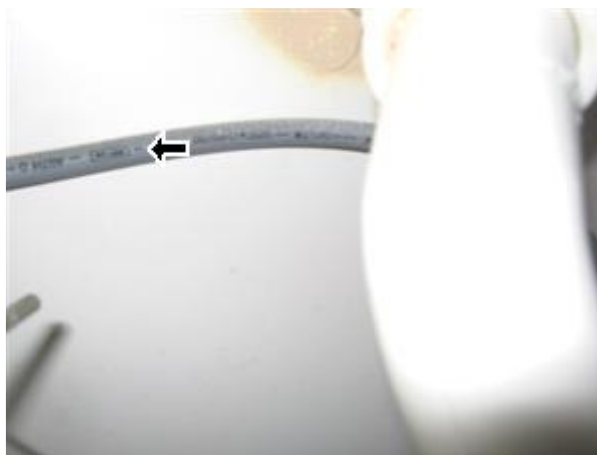
4.3

Polybutylene supply lines are in use, under the sinks etc... Product was part of a class action litigation. Consult manufacturer at www.pbpipe.com for more information.

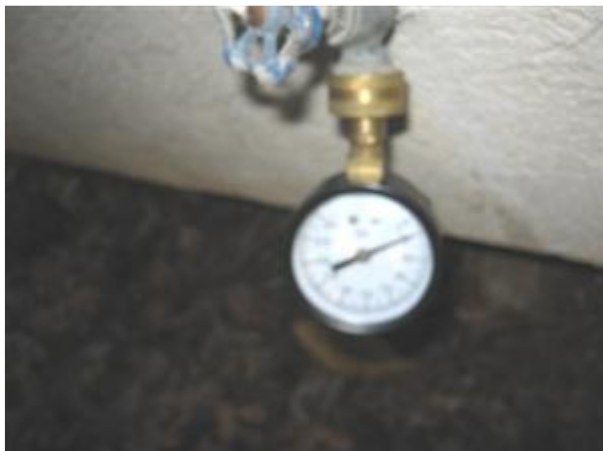
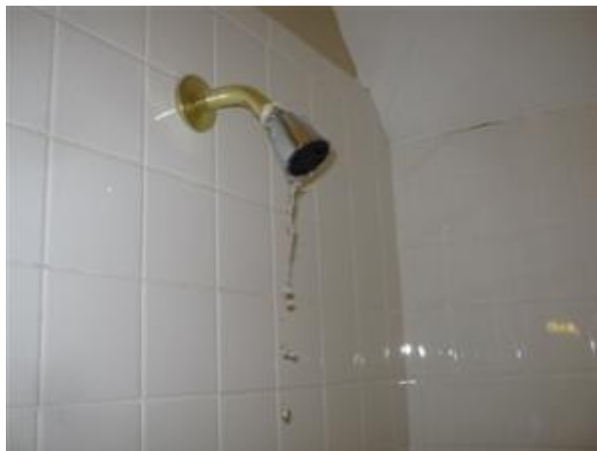
4.4

Low water pressure found on exterior hose bibb, less than 30 lbs. All interior fixture showed very low water flow. Repairs needed.

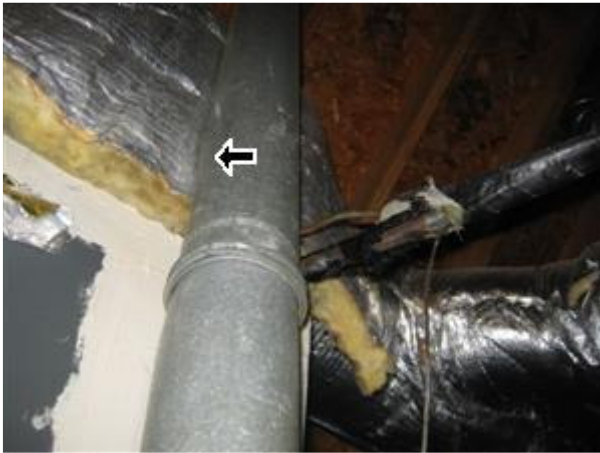
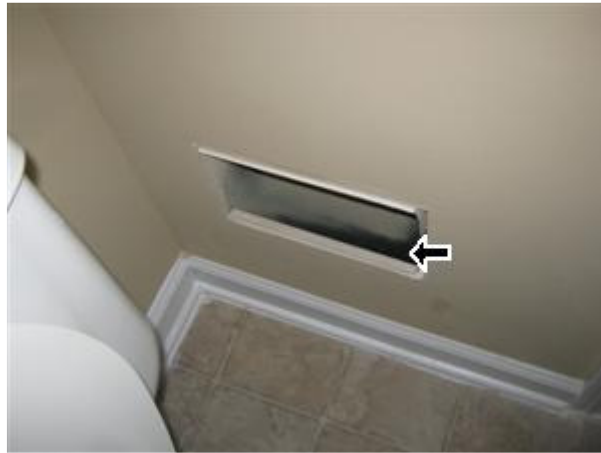
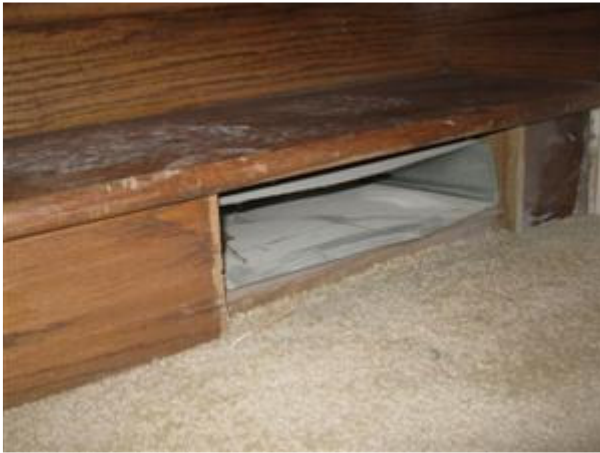
6.3

The furnace flue pipe is in contact with the duct work by the attic unit. A flame shield is needed to be installed between the 2 different materials.

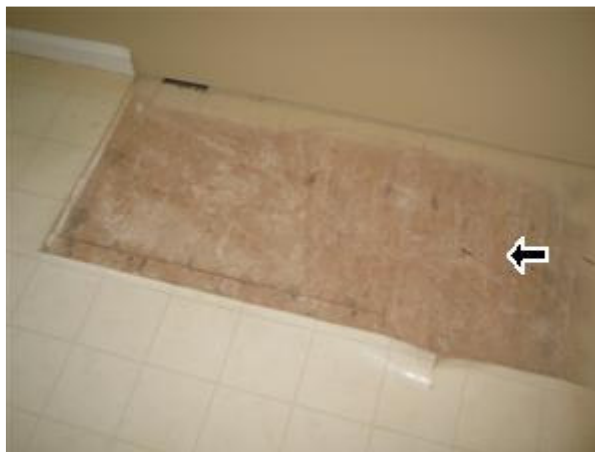
8.8 Picture 2

Floor covering is damage/missing in laundry room. Repair as needed.

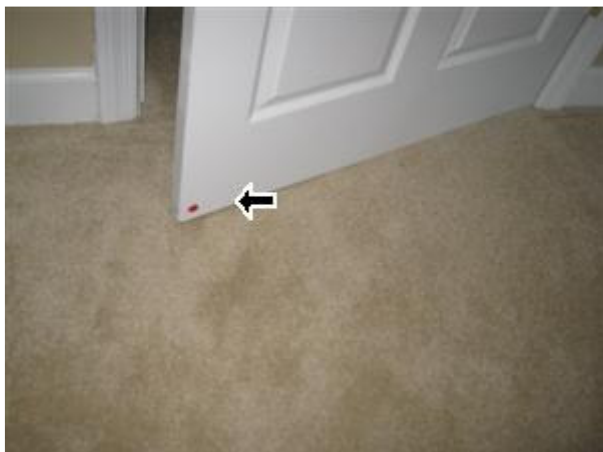
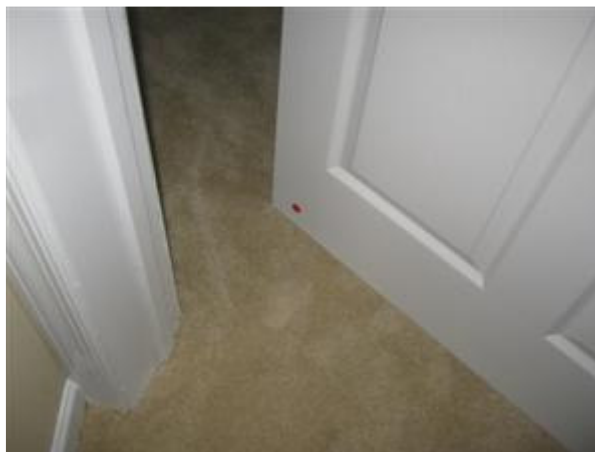
8.11

The marked interior door are sticking at bottom on carpet, adjustment is needed.

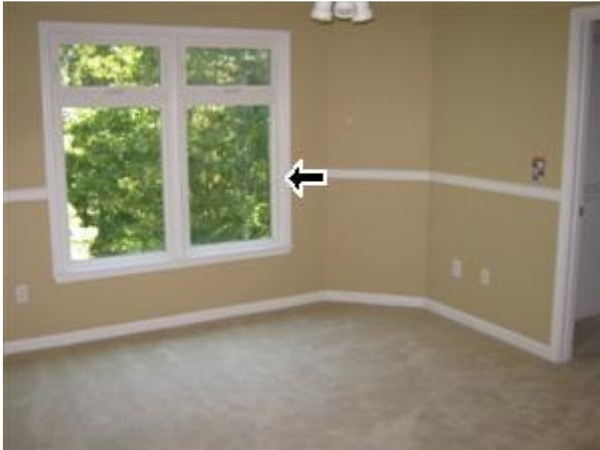
8.14 Picture 1

Marked door handles are loose . Damage on master bedroom door where lock has been removed. Repairs needed.

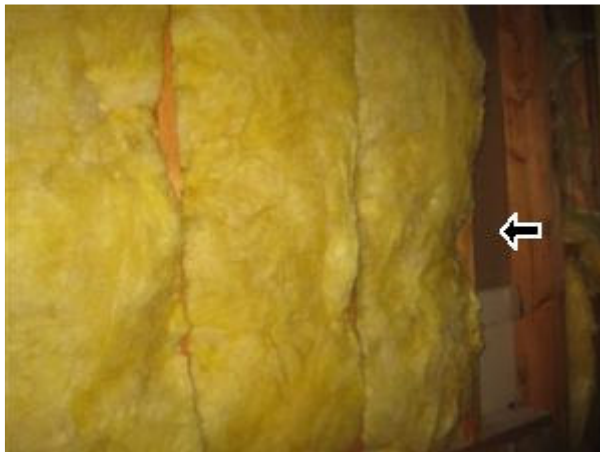
9.0 Picture 1

Insulation is missing in some areas of basement and attic, reinstall insulation where needed.

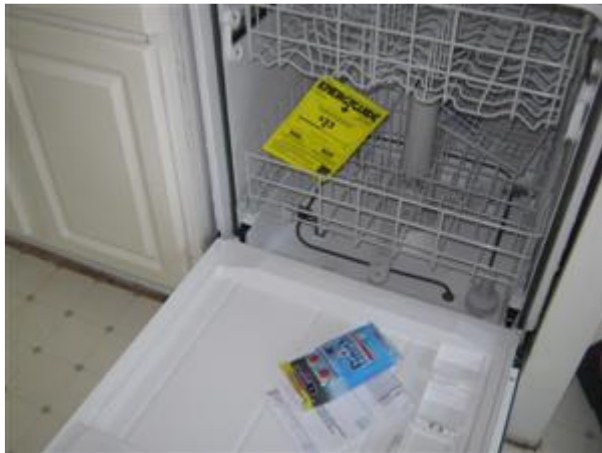
10.0 Picture 1

Unit appears to be new.
