Miller Ranch POA

Reserve Study Update
Project No. 18048

Prepared for
Miller Ranch Property Owners' Association
Edwards, Colorado

May 6, 2019

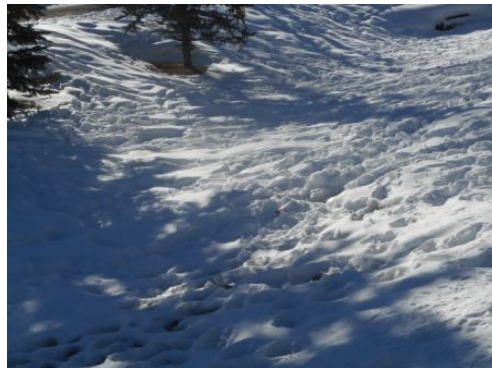
Regrade or clean drainage ditches - 2024

Description: The southern drainage basins/grass swales collect stormwater runoff from the Miller Ranch community, via surface slope, and discharge the runoff off-site through culvert pipes.

Condition: Satisfactory condition. During the site visit there was at least 12" of snow in the drainage ditches.

- Cyclically check and clean debris from the culvert pipes to ensure proper function every year. This cost is not included in the Study because normally associations perform this as a maintenance item and the cost is considered an operating expense.
- Cyclically inspect any erosion or instability of the slopes, clear excessive sedimentation build-up in the basin, monitor settling at bermed areas, and monitor the grass swale conveyance to ensure proper function every year. This cost is not included in the Study because normally associations perform this as a maintenance item and the cost is considered an operating expense.

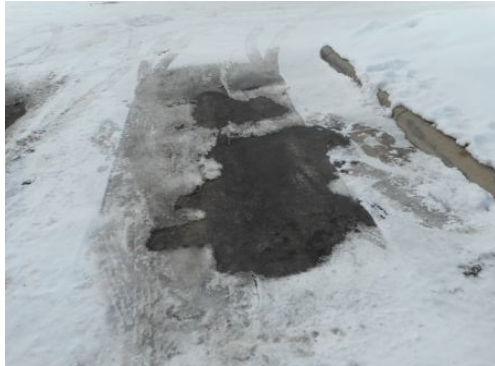
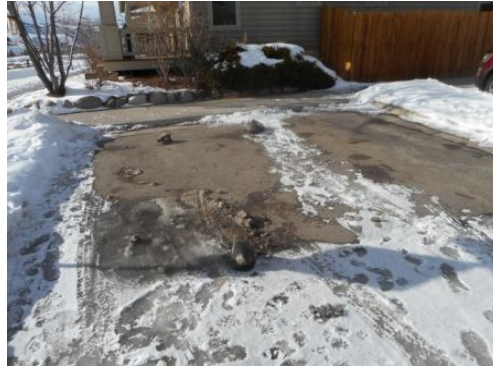
Mill and Overlay parking areas - 2030

Description: Estimated 25,000 square feet of bituminous asphalt pavement.

Condition: Satisfactory condition with low grade raveling/weathering and distortion.

- Mill and overlay and/or full depth patch to replace the asphalt associated with the parking areas, every 18 years, starting in 2030. Prior to this work, we recommend contacting an engineer to recommend the most cost-effective way to perform the work, i.e., some areas of the asphalt may need full depth patch replacement; and other areas may need to be milled and overlaid. Work should be coordinated with the Eagle County road overlay work at Miller Ranch for potential cost savings.

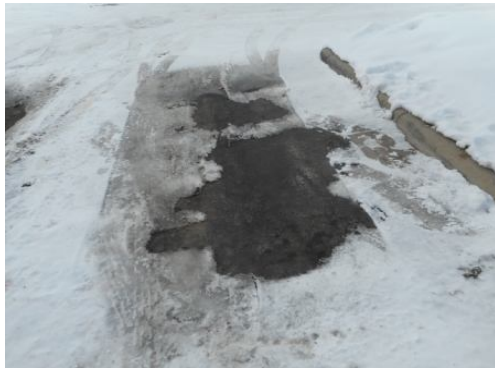
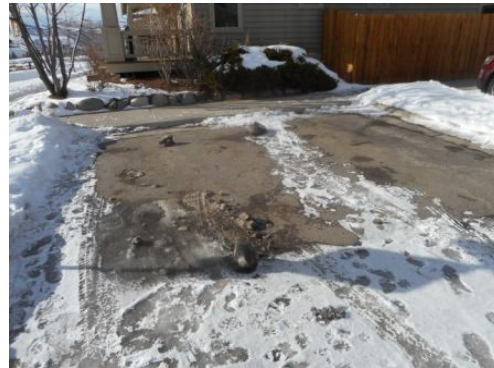
Sealcoat and crack fill - 2020

Description: Estimated 25,000 square feet of bituminous asphalt pavement.

Condition: Satisfactory condition, the association has been sealcoating every 3-4 years.

- Cyclically seal coat and crack fill of the asphalt surface every 4 years, starting in 2020.

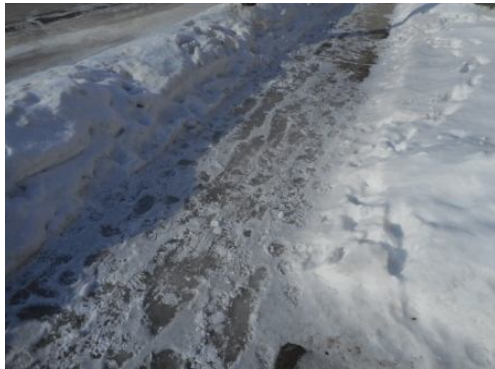
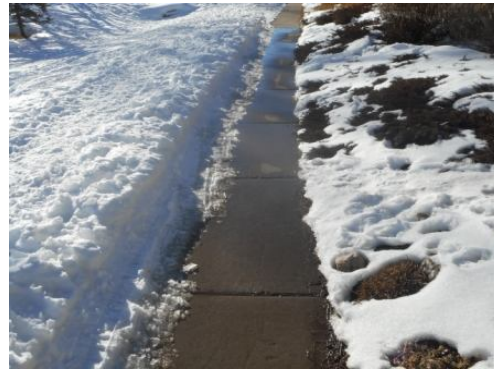
Replace damaged sections - 2021

Description: Estimated 55,535 square feet of walkways are presumed to be on-grade, non-reinforced slabs.

Condition: Satisfactory condition with some cracking, heaving and settling. Some of the cracked areas have settled or heaved resulting in differential edges, which can be a tripping hazard if not corrected. In addition, settled areas of the sidewalks can cause ponding, where drainage gets trapped in the low areas of the sidewalks.

- Cyclically remove and replace damaged sections of the concrete walkways every 3 years, starting in 2021
- Inspect the surface and repair any cracks or deteriorating concrete walkways every year. This cost is not included in the Study because normally associations perform this as a maintenance item and the cost is considered an operating expense.

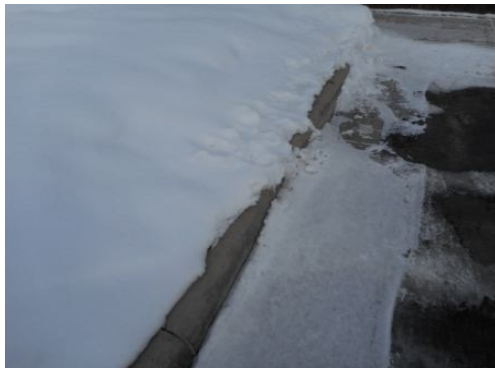
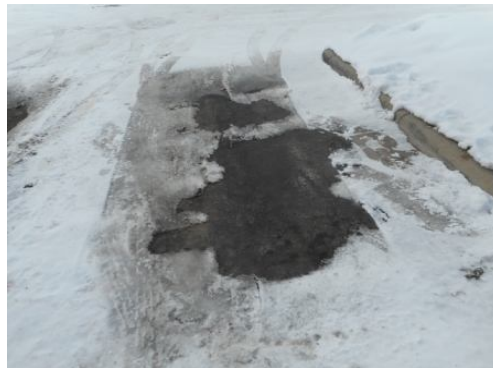
Replace of the damaged sections - 2023

Description: Estimated 2,790 linear feet of concrete curb and gutter adjacent to the parking spaces.

Condition: Satisfactory condition with some cracking, deterioration, settling, and damaged sections noted. Most of the damage to the curb and gutters within the Miller Ranch community are mainly from the heavy use of snow-traction aggregate and chemicals along with snow plowing operations. We were informed that the Association is responsible for the curb and gutters associated with the parking areas.

- Cyclically remove and replace the damaged sections of the concrete curb and gutters every 6 years, starting in 2023.
- Inspect the surface and repair any cracks or deteriorating concrete curbs every year. This cost is not included in the Study because normally associations perform this as a maintenance item and the cost is considered an operating expense.

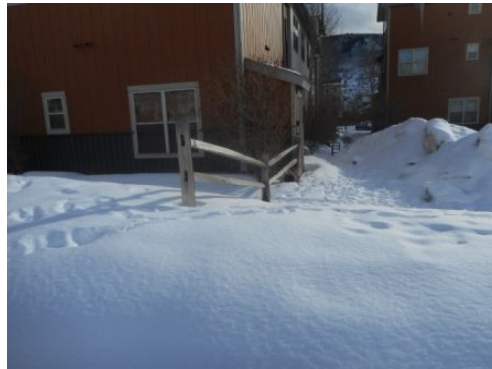
Replace the split rail fencing - 2020

Description: Estimated 20 linear feet of split rail wood fencing.

Condition: Good condition.

- Cyclically remove and replace the split rail fencing every 15 years, starting in 2020. This cost is not included in this Study because the removal and replacement cost is below the minimum threshold of this Study.

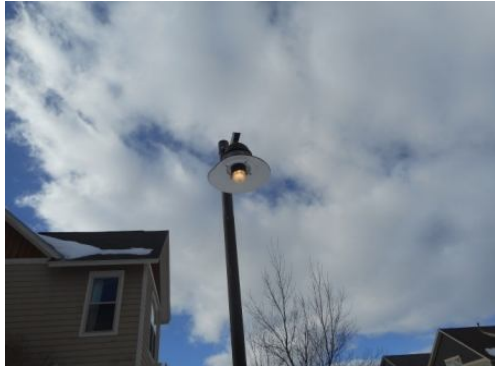
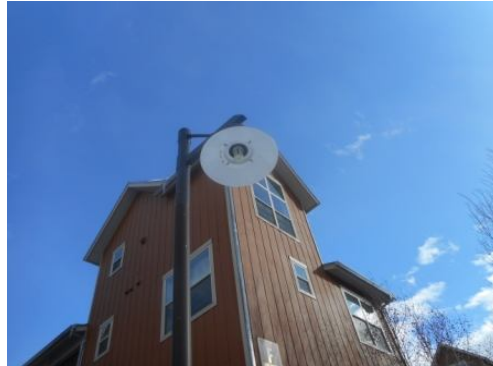
Replace the street lights - 2036

Description: Estimated 25 street lights at an estimated height of 12 feet.

Condition: The site observation was performed during the day, so we cannot verify if lights are in good working condition but aesthetically are in satisfactory condition. The photocells for the street lights may be buried in the snow causing the street lights to remain on during the day. Some streetlights were leaning and should be straightened.

- Remove and replace the street lights in 2036, or as needed. Replacement could be scheduled over multiple years as reserve funds allow.

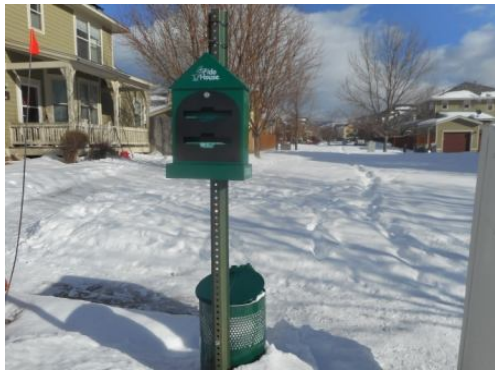
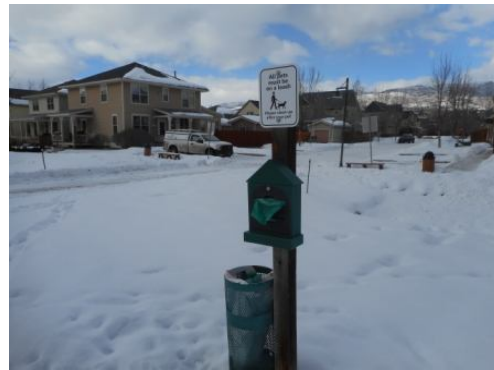
Replace a portion of the pet stations - 2022

Description: Pet stations that have a waste dispenser, pet sign, and trash receptacle that is attached to a green fiberglass telescoping post.

Condition: Satisfactory condition. Pet stations are replaced or added as needed.

- Cyclically remove and replace a portion of the pet stations every 3 years, starting in 2022.

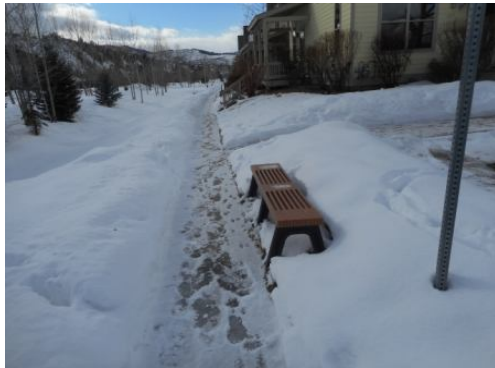
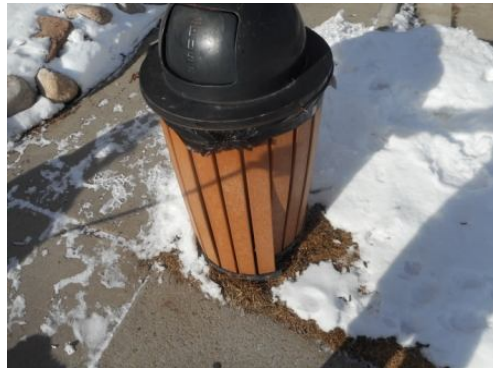
Replace a portion of the benches, trash receptacles and tables - 2020

Description: Trash receptacles that are constructed of 2" vertical wood/hard plastic slats with steel interior framework. Estimated eleven benches that are constructed of rust proof, cast iron frame with wood/hard plastic slats. Estimated four tables that are constructed of hard plastic framing and boards.

Condition: Good to fair condition. Some trash receptacles with missing and/or damaged vertical slats.

- Remove and replace a portion of the benches, trash receptacles, tables every 4 years, starting in 2020.

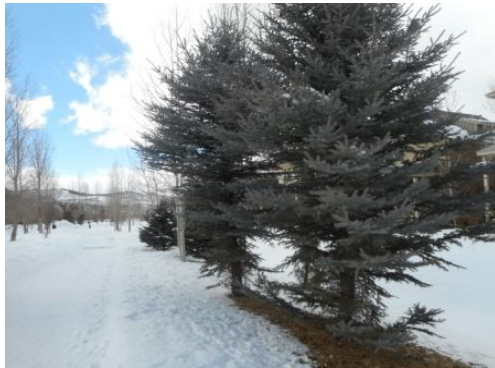
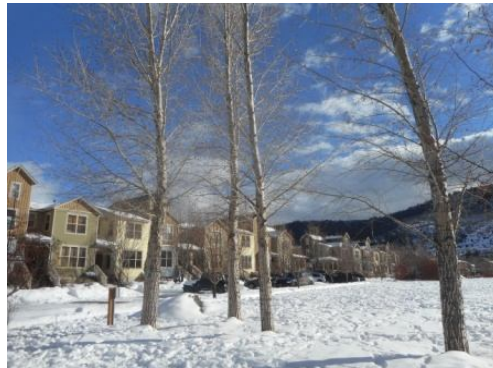
Replace the diseased or dead trees and plants - 2019

Description: Various species of trees, plants, and grass cover.

Condition: Good condition. The Property Owners' Association maintains all landscape within the community which includes landscaping associated with the townhomes and condos. There is landscape budget within the annual operating and maintenance budget for yearly maintenance costs.

- Cyclically remove and replace the diseased or dead trees, plants, and grass cover every year, starting in 2019.
